Town of West Stockbridge Road-Stream Crossing Inventory

Produced by
The Housatonic Valley Association
2021

Executive Summary – August 2021

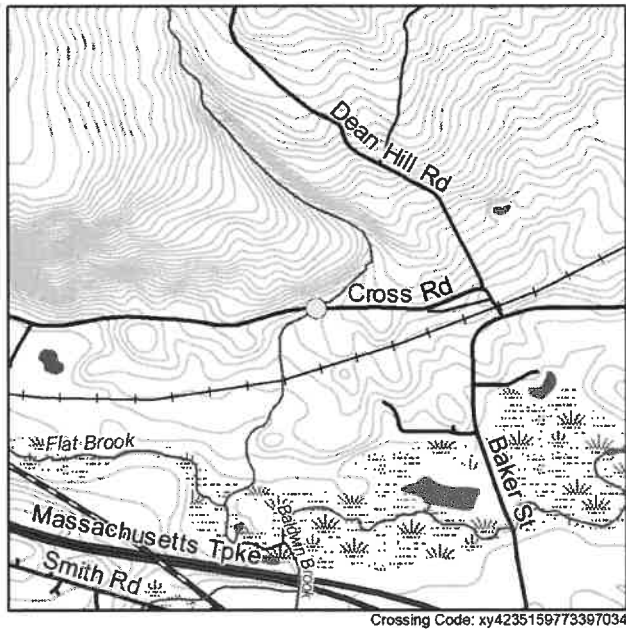
Stream: Unnamed

Barrier Evaluation: Minor barrier

Town Comments on Flooding/Condition/Maintenance: Floods over the road (mostly spring thaw and with intense storms), likely undersized. The upstream hydrology has changed (Richmond property owner channeling water off of hay field to dry it out) - more water volume has been diverted and channeled making this a problem culvert (Potential item for Williams River Watershed-based Plan)

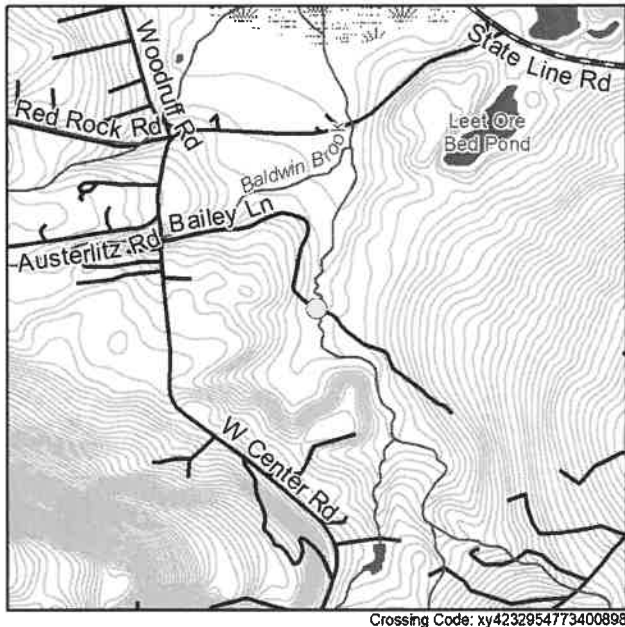
Stream: Unnamed

Barrier Evaluation: Severe barrier
Aquatic Organism Passage Score: 0.07
Town Comments on Flooding/Condition/
Maintenance: No comment
Overall Ranking: Tier 5 (Ranked 7 of 45)

Crossing Type: Culvert
Number of structures/cells: 1
Condition: OK
Constriction: Severe
Alignment: Flow-Aligned
Internal Features/Structures: None

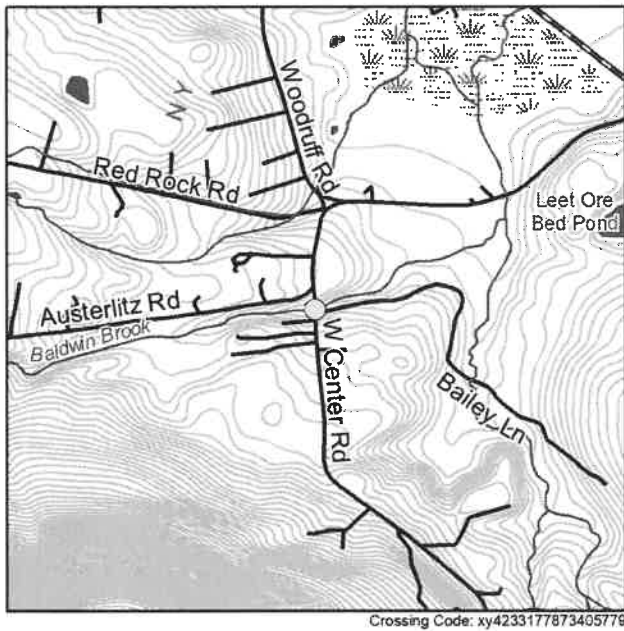
Stream: Baldwin Brook

Barrier Evaluation: Moderate barrier
Aquatic Organism Passage Score: 0.5
Town Comments on Flooding/Condition/
Maintenance: Submitted for MA DER Culvert
Replacement Municipal Assistance grant, but
town does not see major issues with this cross-
ing.

Crossing Type: Culvert
Number of structures/cells: 1
Condition: Poor
Constriction: Moderate
Alignment: Flow-Aligned
Internal Features/Structures: None

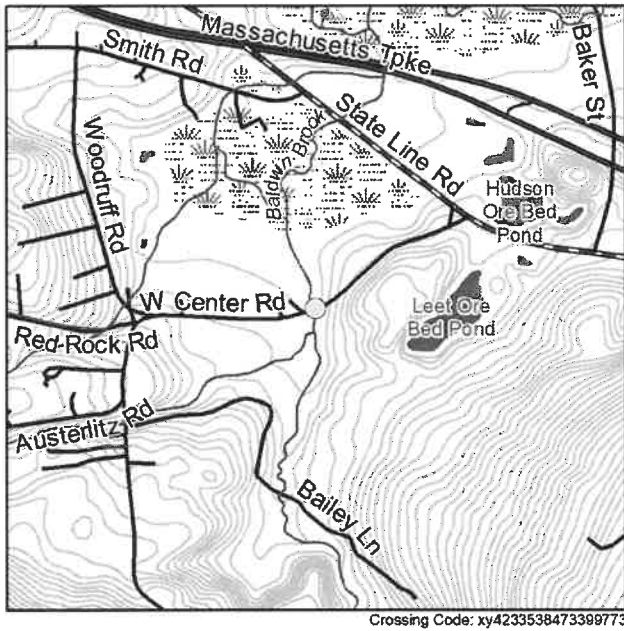
Barrier Evaluation: Insignificant barrier
 Aquatic Organism Passage Score: 0.89
 Town Comments on Flooding/Condition/
 Maintenance: Stormwater/debris clogs up the
 crossing so this structure may be undersized.
 Town has had conversations with state - it could
 qualify for a small bridge grant
 Overall Ranking: Not ranked

Crossing Type: Bridge
 Number of structures/cells: 1
 Condition: OK
 Constriction: Spans Only Bankfull/Active Chan-
 nel
 Alignment: Flow-Aligned
 Internal Features/Structures: None

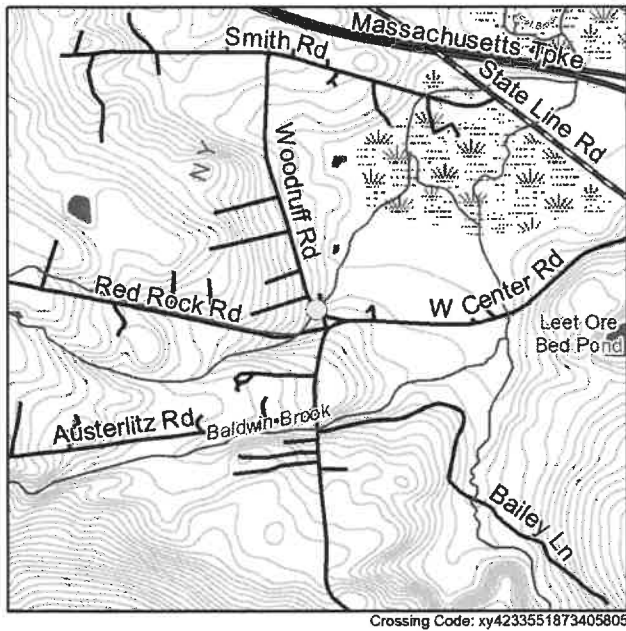
Stream: Unnamed

Barrier Evaluation: Significant barrier
Aquatic Organism Passage Score: 0.22
Town Comments on Flooding/Condition/
Maintenance: Not a town priority - crossing has
been worked on recently and improved.
Overall Ranking: Tier 5 (Ranked 7 of 45)

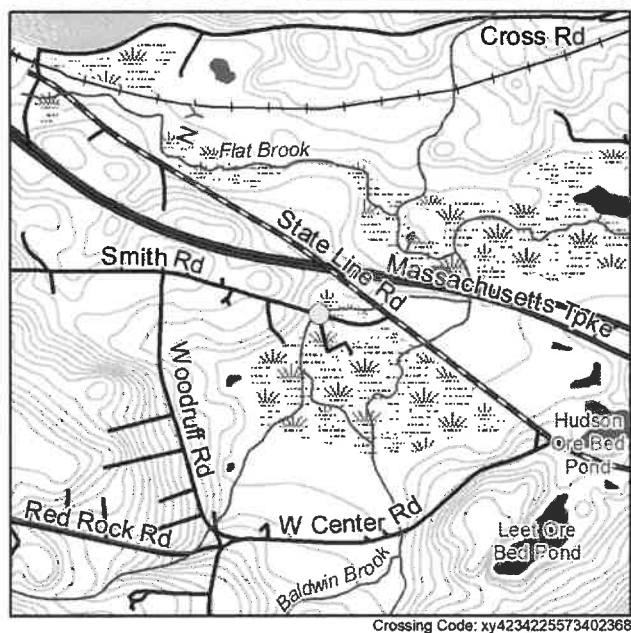
Stream: Unnamed

Barrier Evaluation: Moderate barrier
Aquatic Organism Passage Score: 0.43
Town Comments on Flooding/Condition/
Maintenance: #3 Priority - Beaver issues - whole
road floods from State Road to the crossing.
Overall Ranking: Tier 5 (Ranked 7 of 45)

Crossing Type: Multiple Culvert
Number of structures/cells: 2
Condition: OK
Constriction: Severe
Alignment: Flow-Aligned
Internal Features/Structures: None

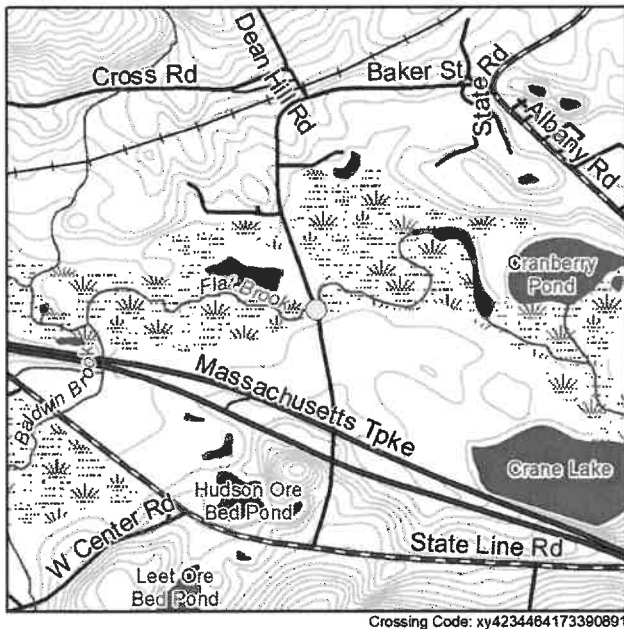
Stream: Unnamed

Barrier Evaluation: no score - missing data
Aquatic Organism Passage Score: No data
Town Comments on Flooding/Condition/Maintenance:
#2 Priority - Flooding issues, likely undersized. Flat Brook is a major trib of the Williams River and it flows through Wildlife Management Area - Baker Street is in the middle of this WMA. This structure is in the top 5% in MA Climate Action Tool.
Overall Ranking: Tier 5 (Ranked 7 of 45)

Crossing Type: Partially Inaccessible
Number of structures/cells: 2
Condition: No data
Constriction: Severe
Alignment: Flow-Aligned
Internal Features/Structures: No data

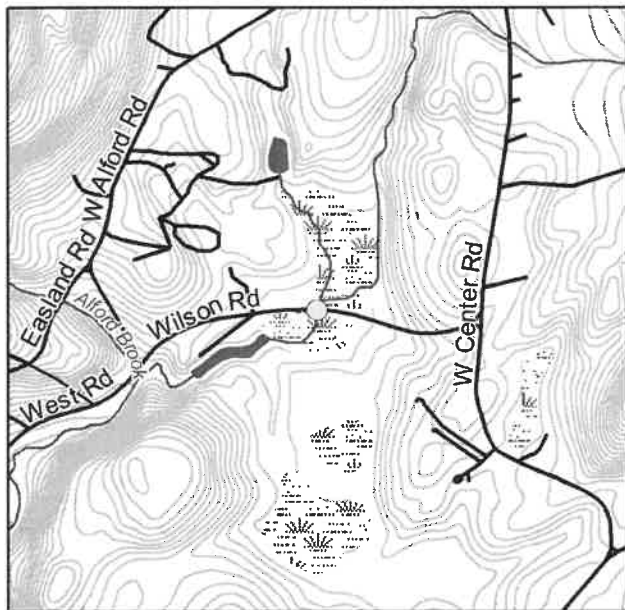
Stream: Alford Brook

#1 Priority - Beaver issues - no deceiver - Alford Brook Club may be supportive of replacement, would prefer to not have beaver upstream of their trout pond. Road floods and it is undermining the road. This was a bacteria monitoring site and the water level is consistently almost at the road level. On MA OLIVER as a CFR. Alford Brook Club maintains a trout pond for its members (downstream of this crossing). Alford Brook Club owns property adjacent to the crossing which floods almost to the basement windows of the structure. Willson Road is scheduled for repaving in 2022

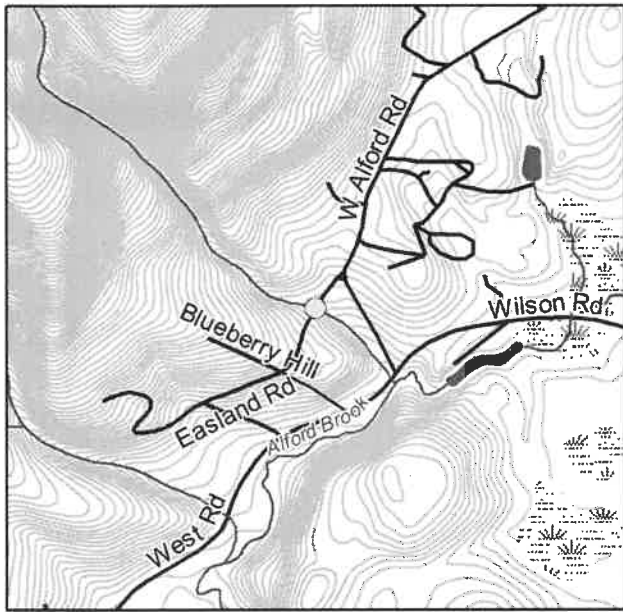
Barrier Evaluation: Severe barrier
 Aquatic Organism Passage Score: 0.02
 Town Comments on Flooding/Condition/
 Maintenance: No comment
 Overall Ranking: Tier 3 (Ranked 4 of 45)

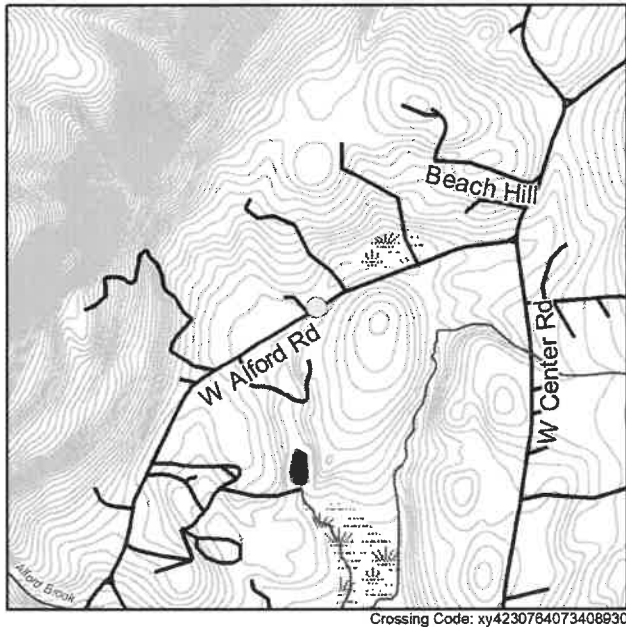
Stream: Alford Brook

Barrier Evaluation: Significant barrier
Aquatic Organism Passage Score: 0.29
Town Comments on Flooding/Condition/
Maintenance: Beaver Issues - floods over the
road

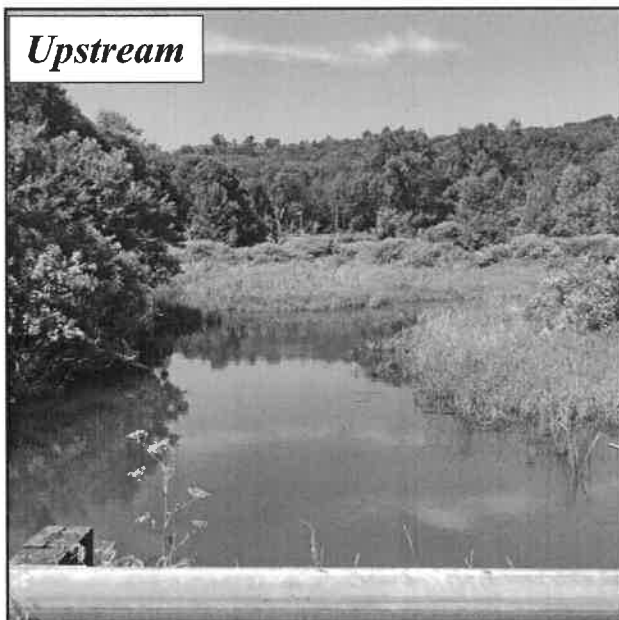
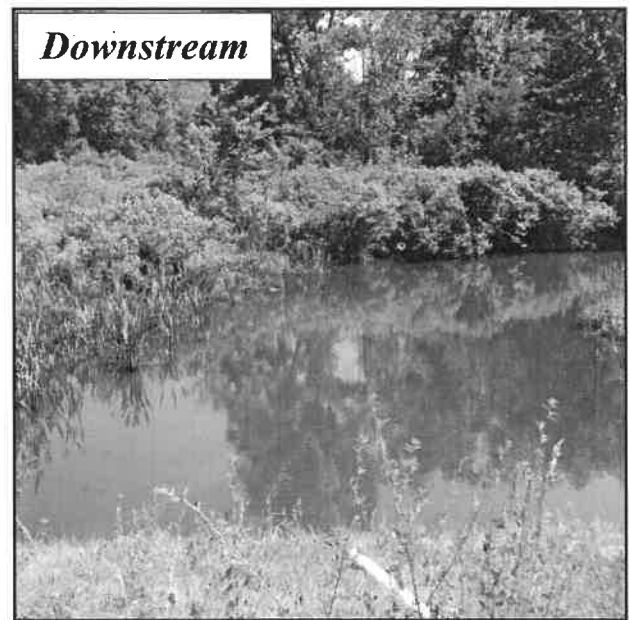
Crossing Comments: Stream crossing and many measurements and photos are almost completely inaccessible due to high water from wetland. May be more accessible during extremely low flow conditions.
