**-- SHAKER MILL POND DAM --**  
**PHASE I**  
**INSPECTION / EVALUATION REPORT**

Dam Name: *Shaker Mill Pond Dam*

National ID No.: *MA 00732*

Date of Inspection: *August 8, 2023*

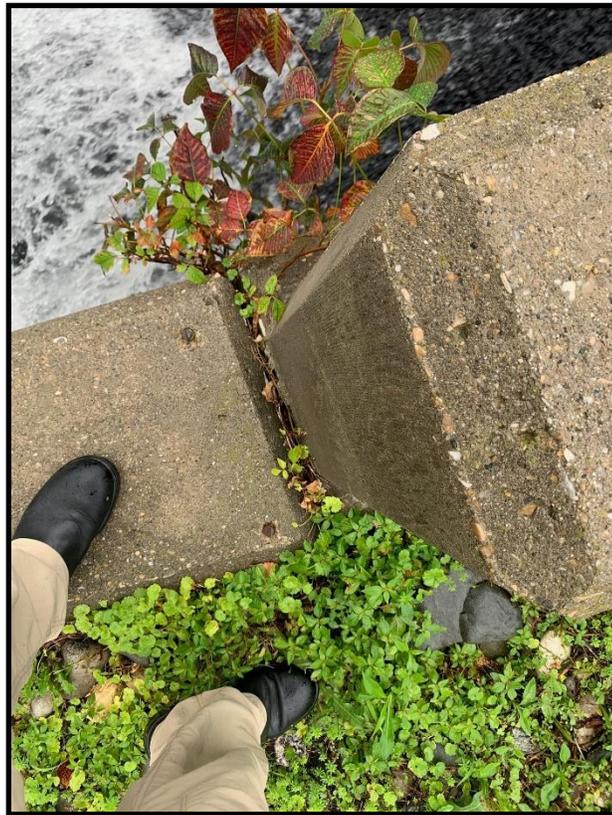
*21A. Area of deficiency: Joint caulk missing*

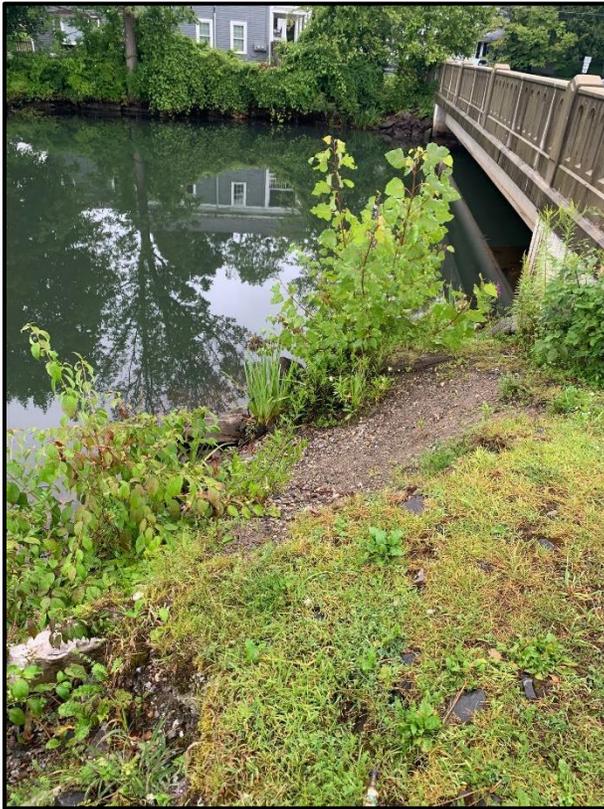
area of erosion, an 18 inch wide sinkhole, at the upstream right embankment adjacent to the bridge end due to a broken culvert below. This eroded sinkhole found in 2020 was not found in the 2023 inspection due to dense vegetation.

*22. Area of deficiency: Erosion at right embankment at bridge end from upstream*

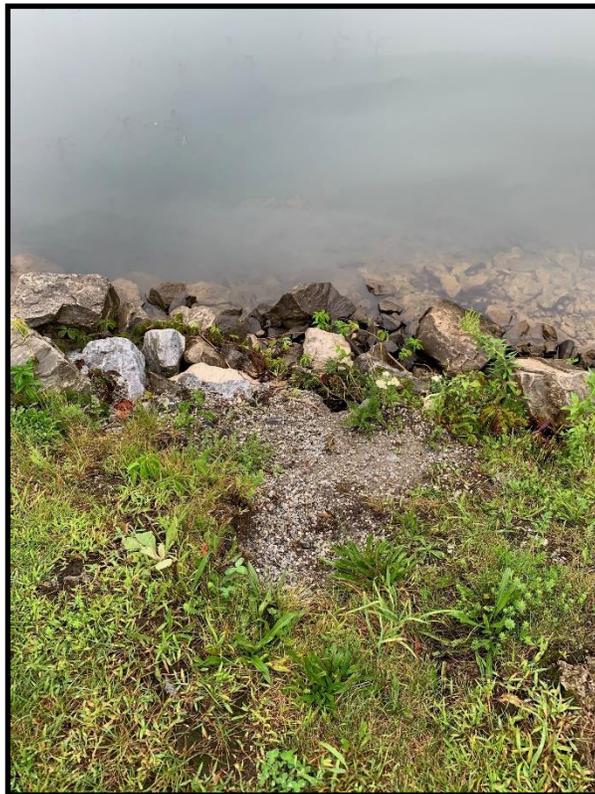
*23. Area of deficiency: Debris/erosion at left embankment at bridge end from upstream*

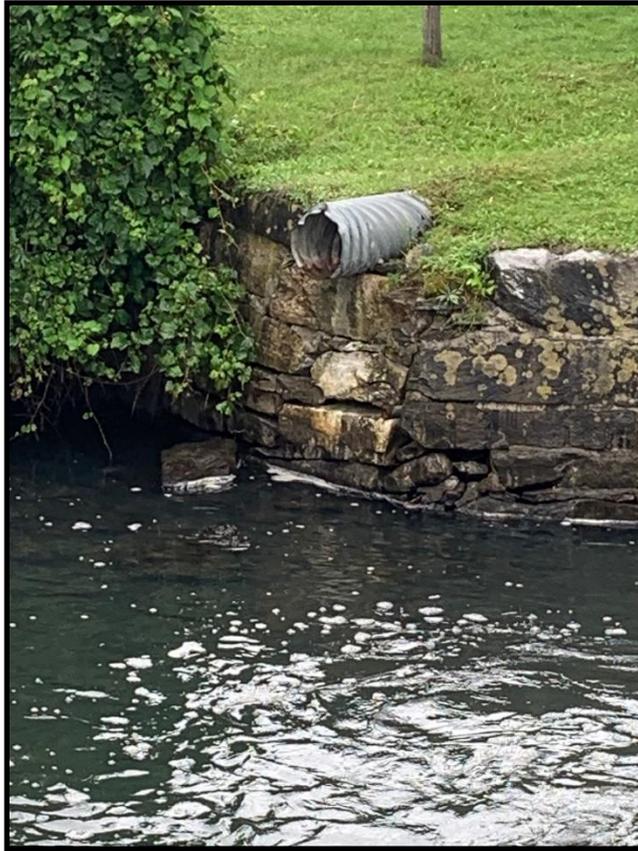
Concrete spillway training walls transition to stone masonry walls which contain the Williams River downstream of the dam. The rebuilt portion of the left wall appears to be in good condition. There is a minor sinkhole on the capstone and undermined stones at the base of the right downstream wall.

*24. Area of deficiency: Undermined stone at base of right downstream masonry wall*

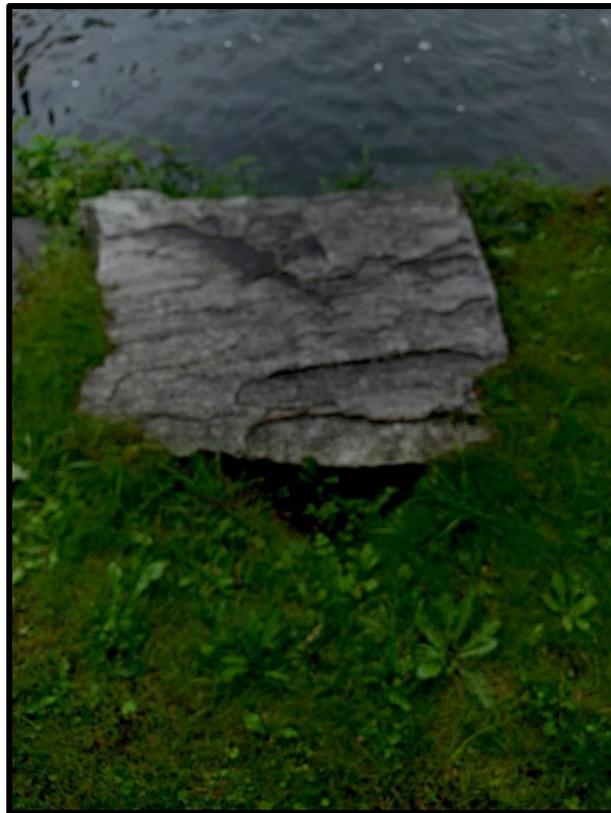
The abutments of the Shaker Mill Pond Dam were in generally good condition. The easterly downstream training wall was repaired in 2017. There is minor spalling on the upstream face of the left concrete bridge abutment. Right downstream wall has a small sinkhole adjacent to an existing culvert outlet and wall stones appear to be moving.

*25. Area of deficiency: Sinkhole at right side of downstream masonry wall capstone*

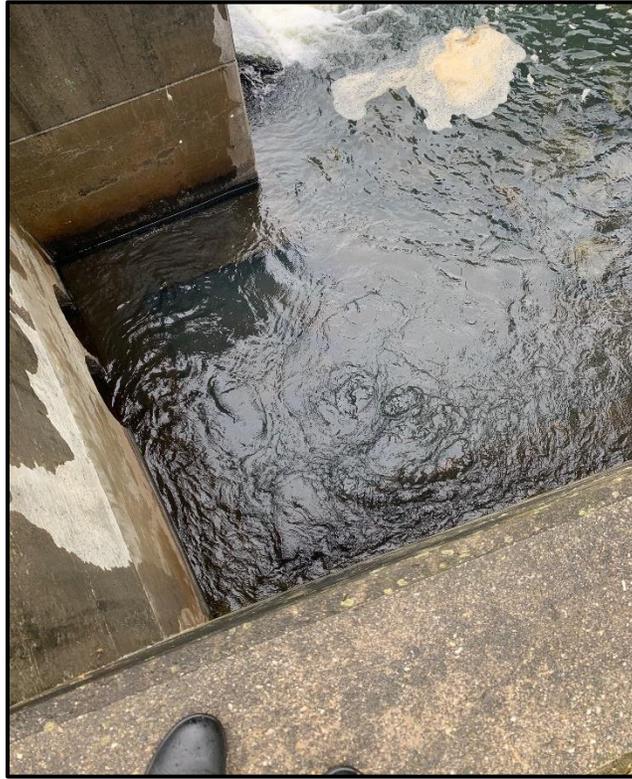
Although the seepage condition rating is ‘poor’ following ODS requirements (evidence of monitored piping and seepage), given the history and the involvement of DEM in the past construction and inspection of the boil, it appears unlikely to constitute a significant structural deficiency and thus does not warrant a ‘poor’ overall dam condition rating. It is recommended, however, that the Town continue to monitor the boil regularly, as they have since 1995 and observe the embankment for signs of settlement or void formation.

Our observations at the time of the current inspection align with the 2009 report and we recommend the same monitoring of the boil.

26. Area of deficiency: *Boiling at base of hydro area*

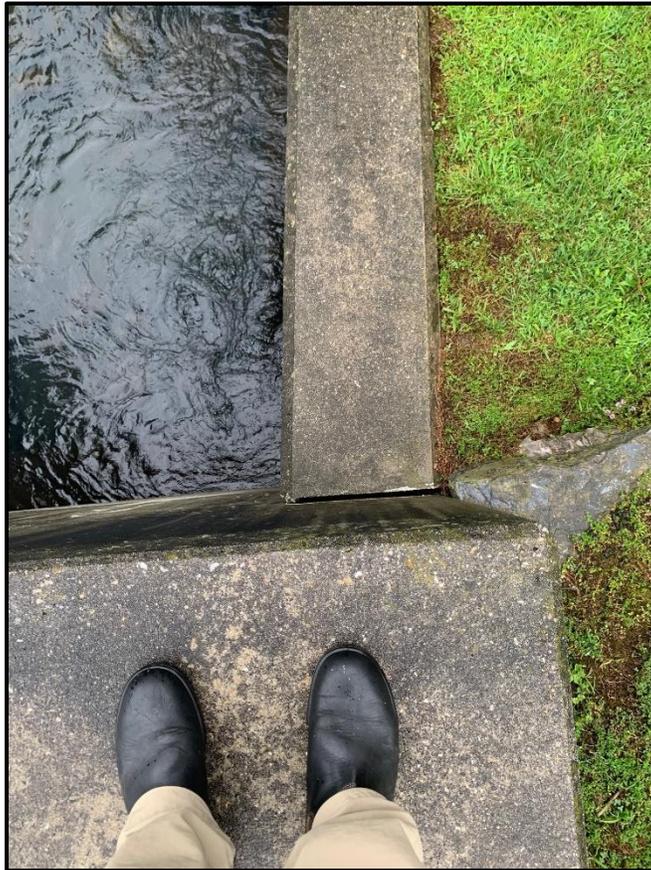
The joint caulk in the concrete portion of the downstream wing walls has deteriorated and is allowing vegetation and dirt into the joints.

27. Area of deficiency: *Deteriorated joint caulk at downstream concrete joint*
