Town of West Stockbridge Road-Stream Crossing Inventory

Produced by
The Housatonic Valley Association
2021

Executive Summary – August 2021

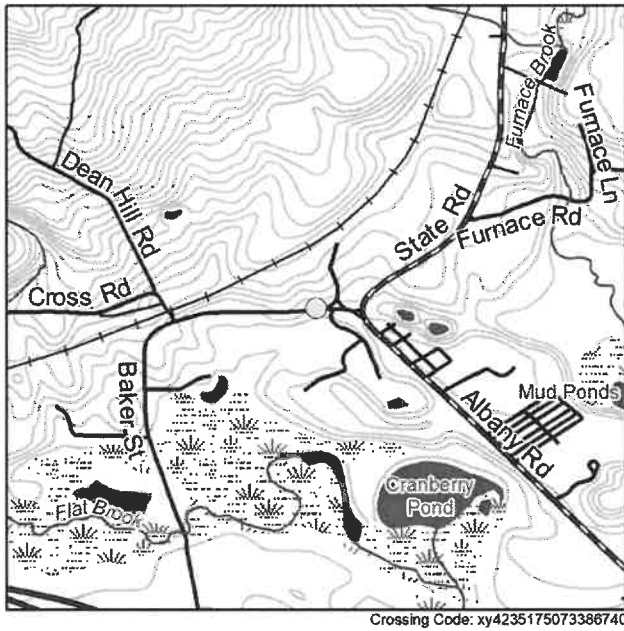
Road: Baker Street

Barrier Evaluation: no score - missing data
Aquatic Organism Passage Score: No data
Town Comments on Flooding/Condition/
Maintenance: No comment
Overall Ranking: Tier 11 (Ranked 33 of 45)

Crossing Type: Partially Inaccessible
Number of structures/cells: 1
Condition: OK
Constriction: Unknown
Alignment: Flow-Aligned
Internal Features/Structures: None

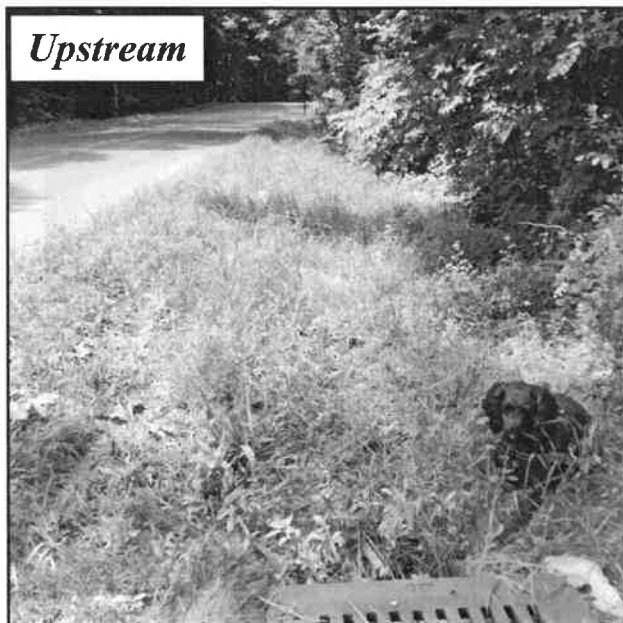
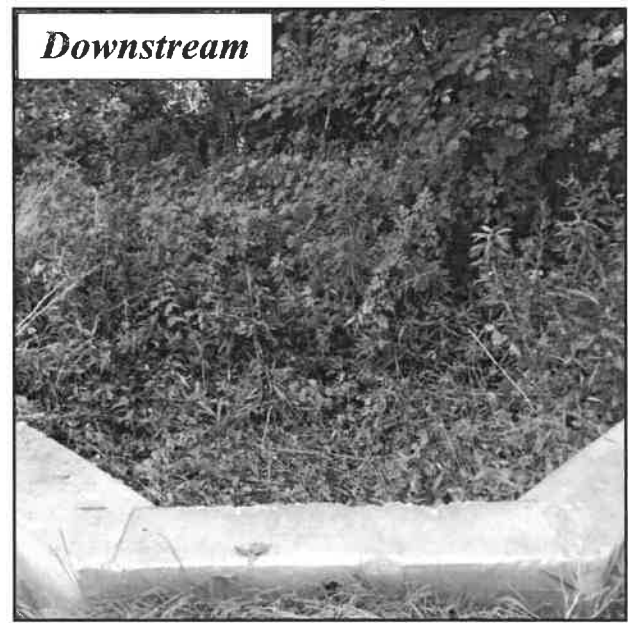
Crossing Comments: Inlet is a box with a drop inside to a plastic pipe that is inaccessible.

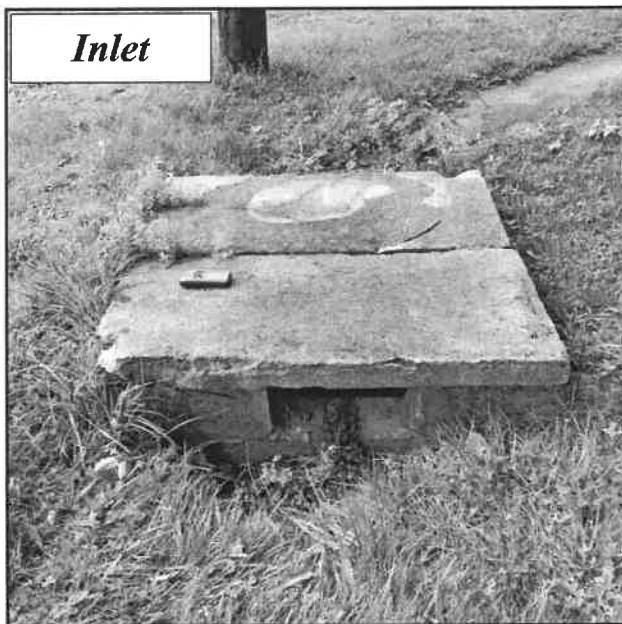
**INLET**

Structure Comments: Inlet opening is inaccessible due to concrete structure surrounding inlet. Water flows into concrete structure from the top in two directions.

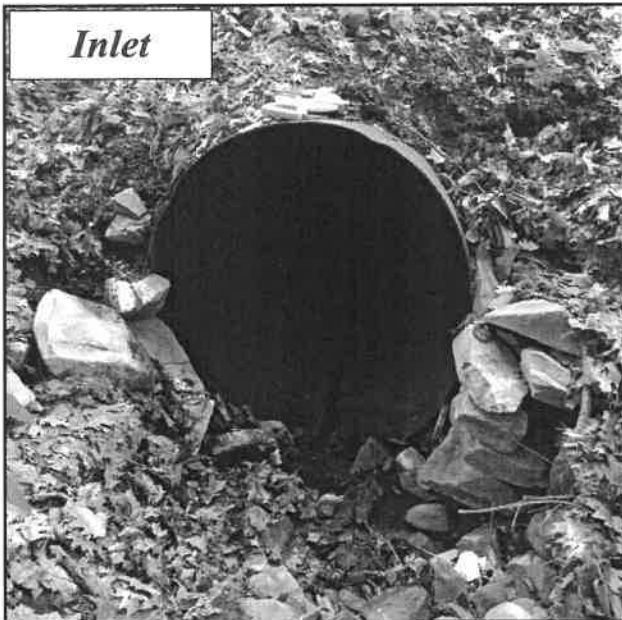
INLET

Structure Comments: Pipe is dry because water goes under the pipe.

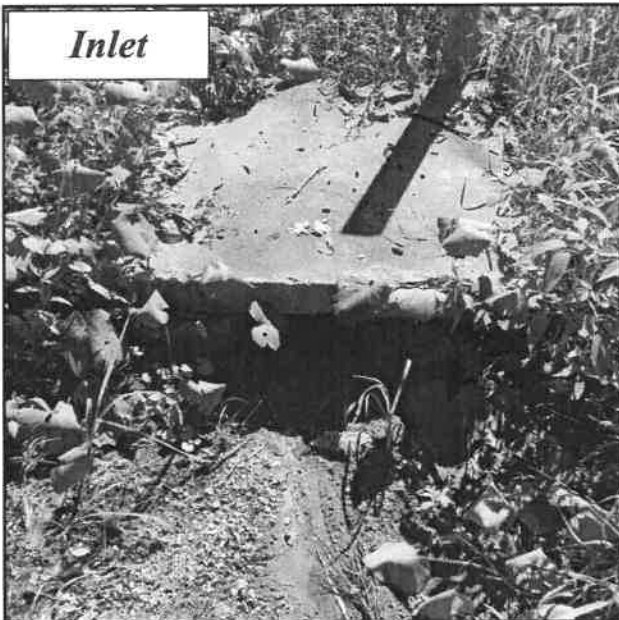
INLET

Crossing Comments: Inlet inaccessible due to concrete slab over top. Other photo is a close-up of the outlet. May be for stormwater.

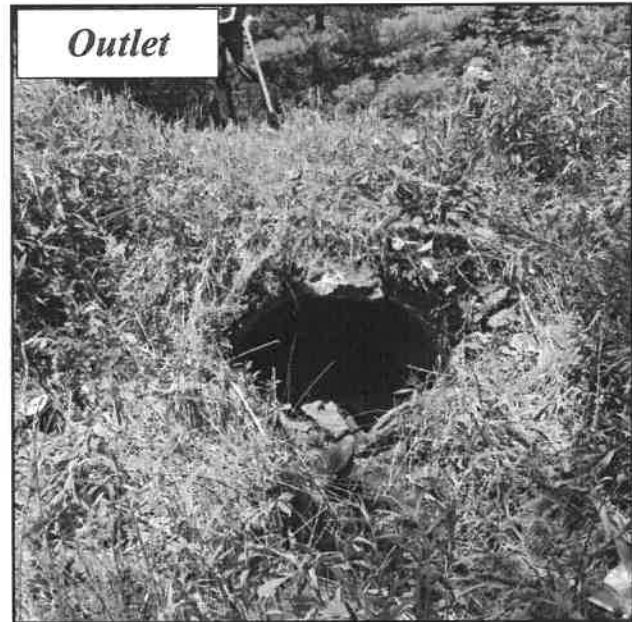
OUTLET

Structure Comments: Rock around culvert is collapsing at the outlet. Sediment in crossing is just built up at outlet end.

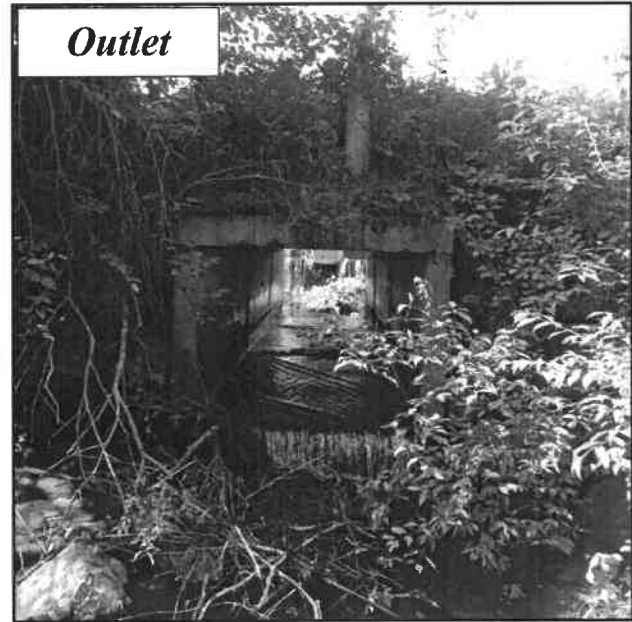
OUTLET

Outlet Shape: Box Culvert
Outlet Drop/Grade: Free Fall Onto Cascade
Drop to Stream Surface/Bottom: 1.6/3.6
Dimensions:
Width: 5.0, Height: 4.0
Substrate/Water Width: 5.0
Water Depth: 0.20

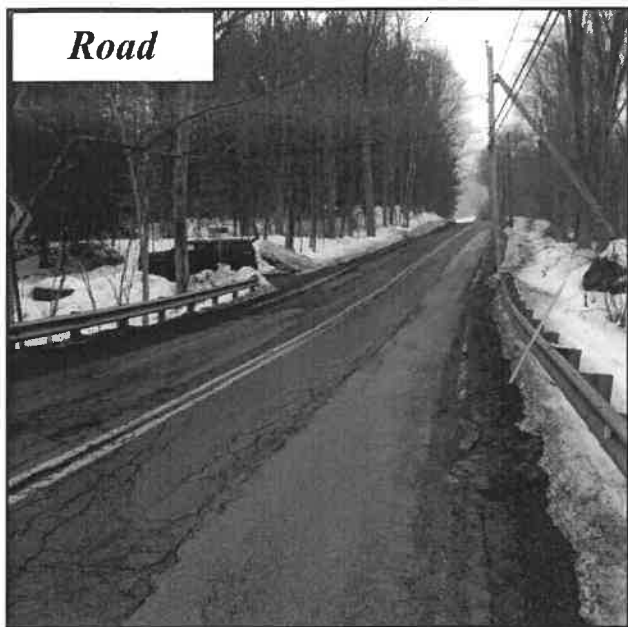
ROAD

Physical Barrier(s) (Severity): Deformation (Minor)
Slope (%): No data
Structure Comments: No data

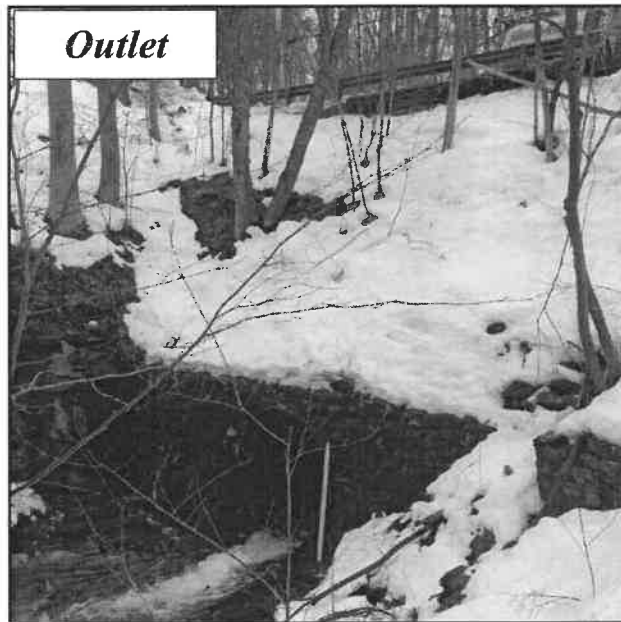
OUTLET

Outlet Shape: Round Culvert
Outlet Drop/Grade: Free Fall
Drop to Stream Surface/Bottom: 0.5/0.7
Dimensions:
Width: 6.0, Height: 6.0
Substrate/Water Width: 3.0
Water Depth: 0.20

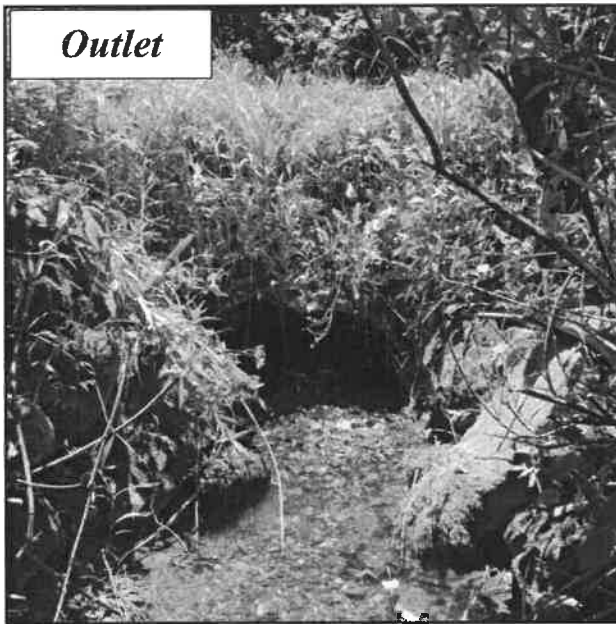
**OUTLET**

Structure Comments: Outlet is deformed caving in vertically

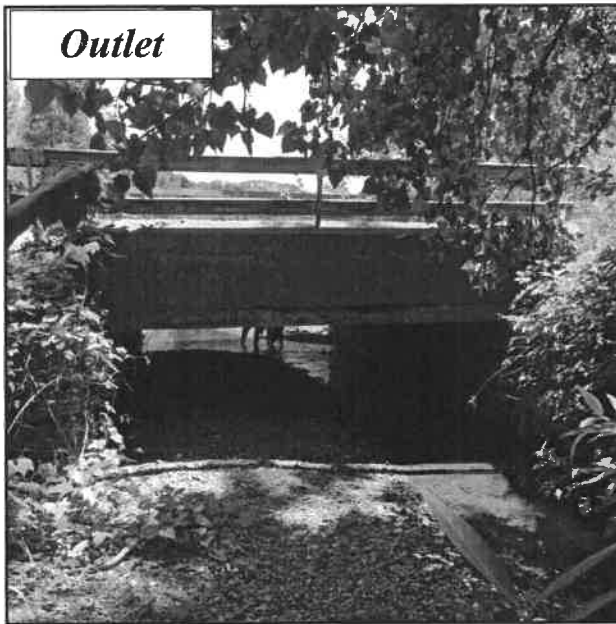
OUTLET

Physical Barrier(s) (Severity): None
Slope (%): No data
Structure Comments: Head wall at outlet is falling outward. Bridge made of concrete metal with

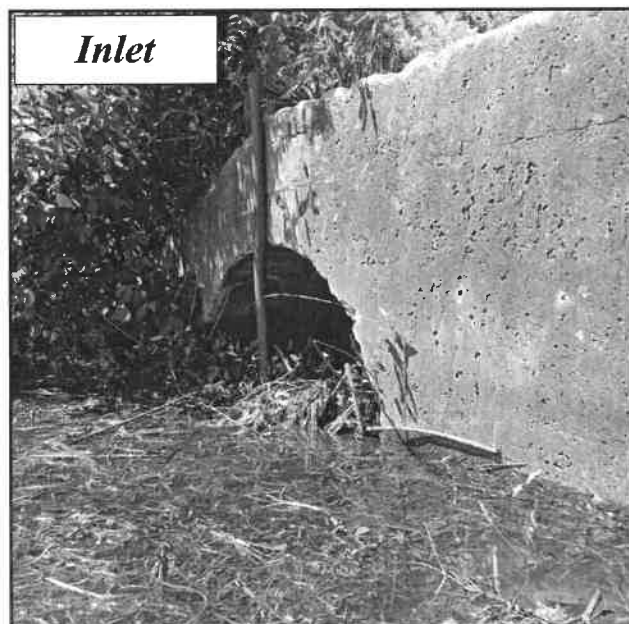
INLET

Physical Barrier(s) (Severity): Debris/Sediment/
Rock,Free Fall,Fencing (Severe)
Slope (%): 1
Structure Comments: Inlet water depth is estimated.

Inlet Shape/Type: Round Culvert/Headwall
Inlet Drop/Grade: Inlet Drop
Dimensions:
Width: 5, Height: 5
Substrate/Water Width: 3.5
Water Depth: 1

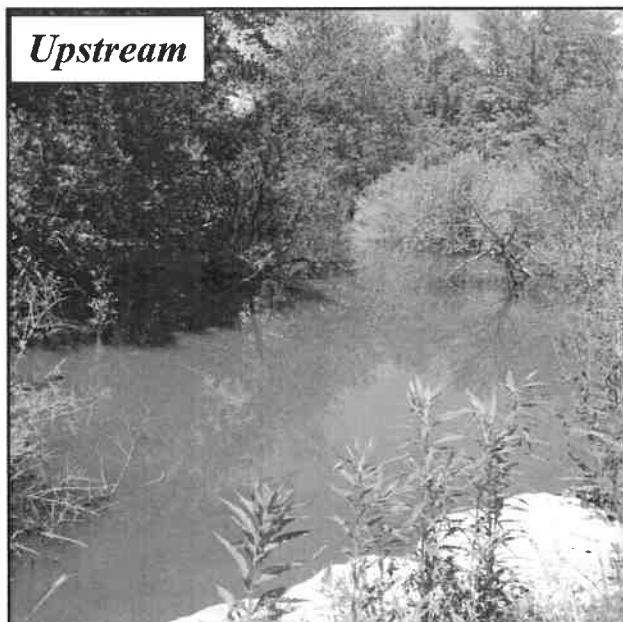
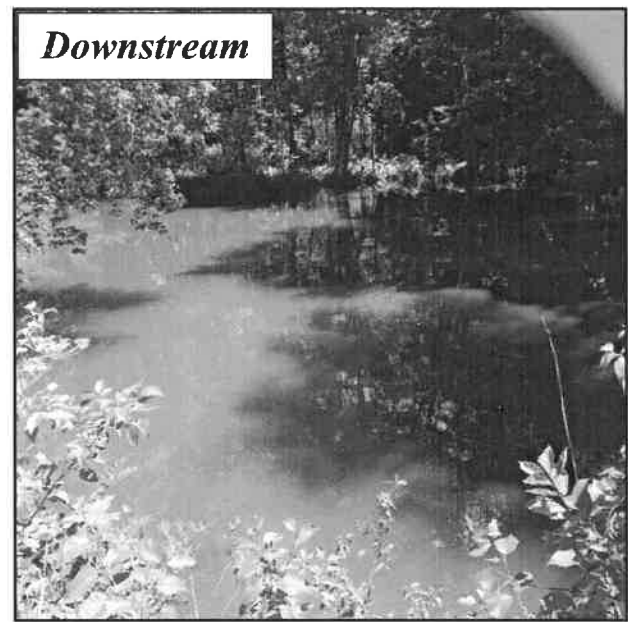
Crossing Comments: Crossing is somewhat inaccessible due to very deep water in wetlands. Some measurements were estimated and photos difficult to get

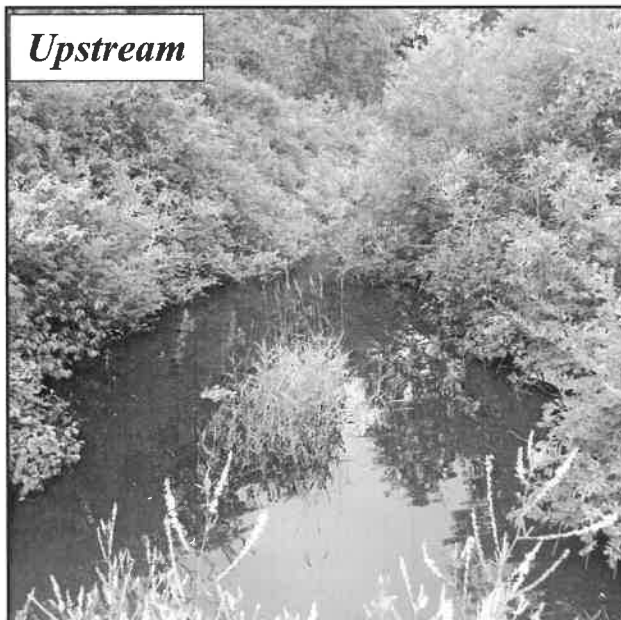
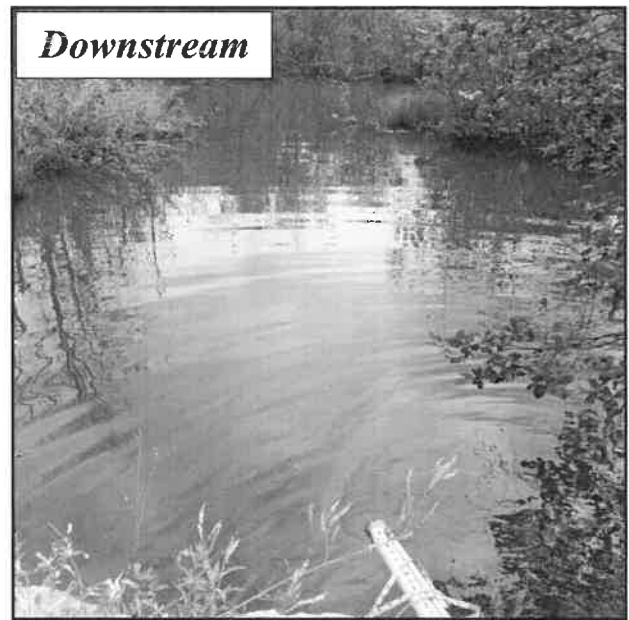
Crossing Comments: Just north of the Balwin Brook crossing on Baker Street - probable that this is also part of Balwin Brook, but not confirmed

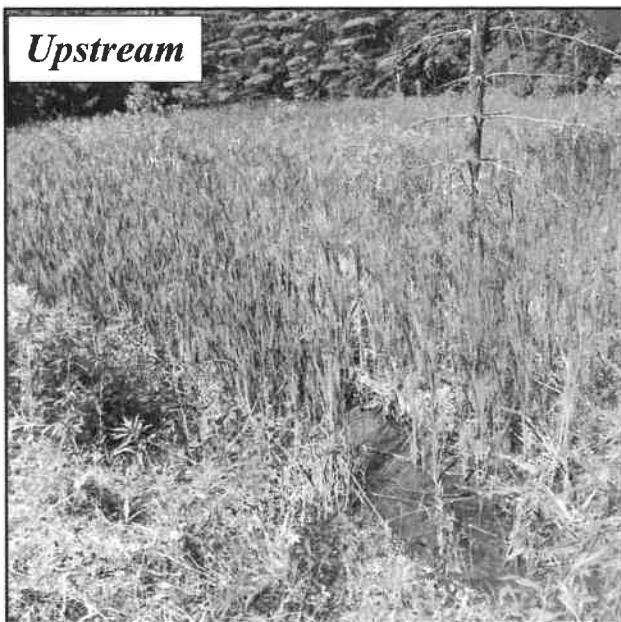
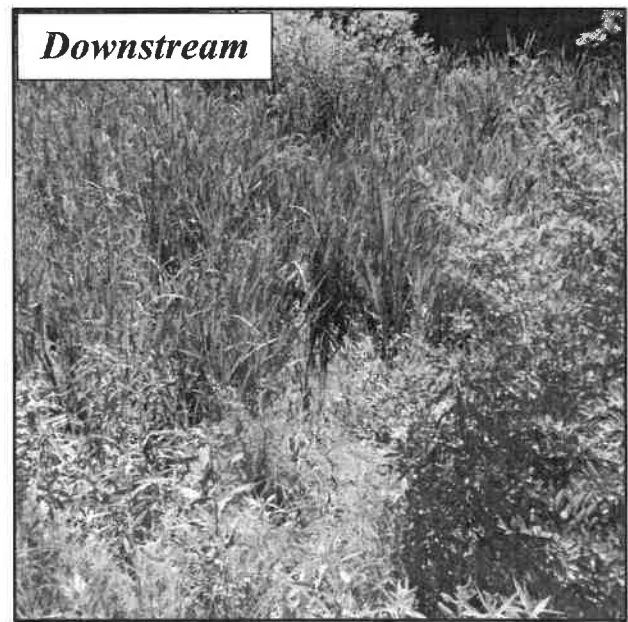
Crossing Comments: Culvert connects wetlands on either side of road. Culvert is partially inaccessible

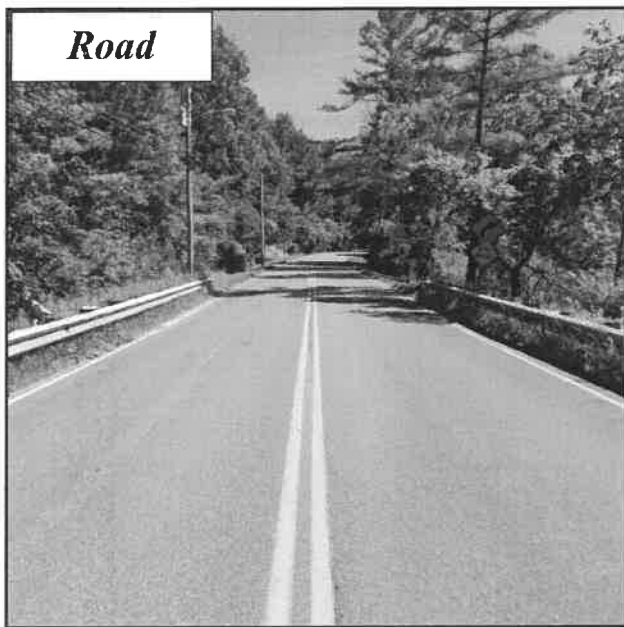
Road

Structure Comments: Structure mostly inaccessible height and width estimated . Structure length estimated

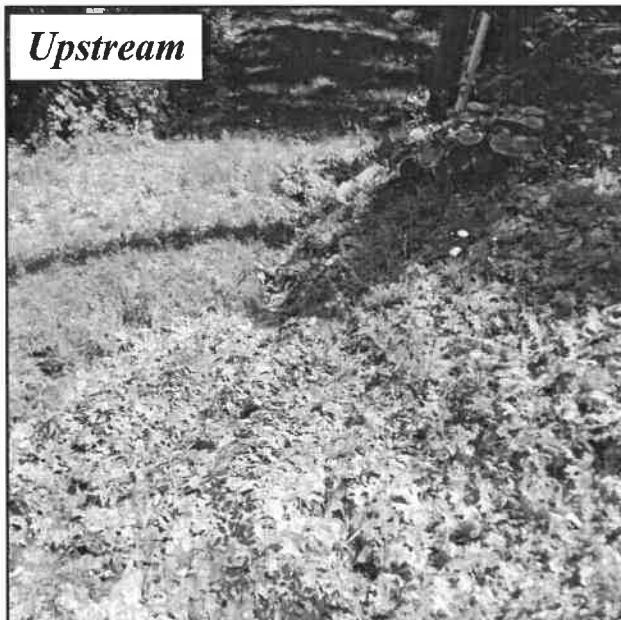
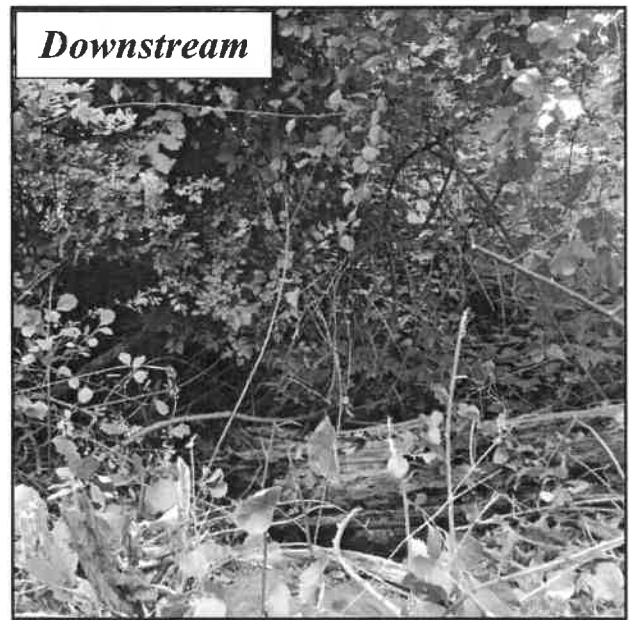
Crossing Comments: Outlet photo difficult to get due to large fallen log and thick vegetation

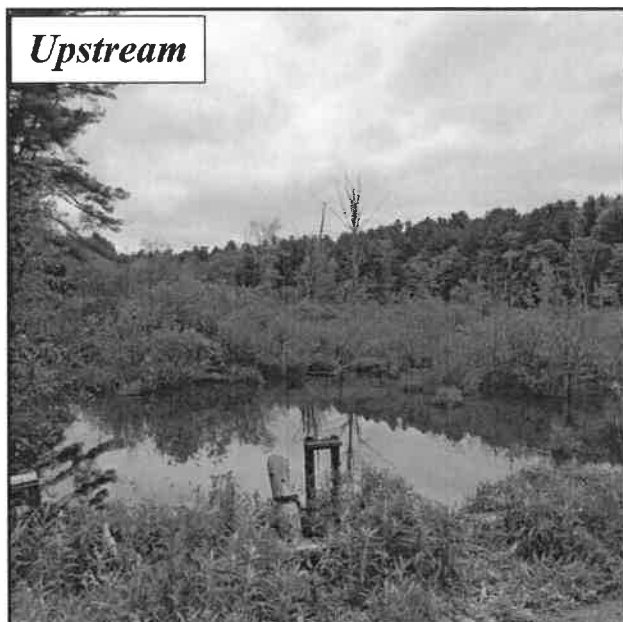
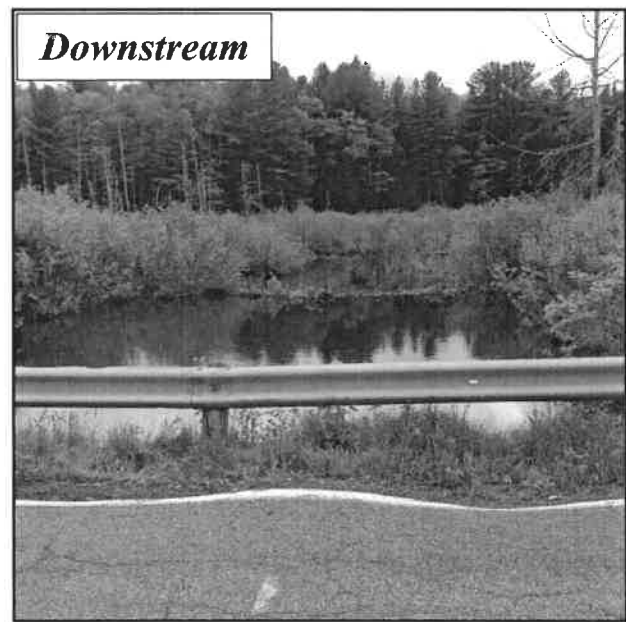
#1 Priority - Beaver issues - no deceiver - Alford Brook Club may be supportive of replacement, would prefer to not have beaver upstream of their trout pond. Road floods and it is undermining the road. This was a bacteria monitoring site and the water level is consistently almost at the road level. On MA OLIVER as a CFR. Alford Brook Club maintains a trout pond for its members (downstream of this crossing). Alford Brook Club owns property adjacent to the crossing which floods almost to the basement windows of the structure. Willson Road is scheduled for repaving in 2022

Crossing Comments: Difficult to see pipes, road surface in bad shape, beaver activity, wetland connection, pipes completely submerged

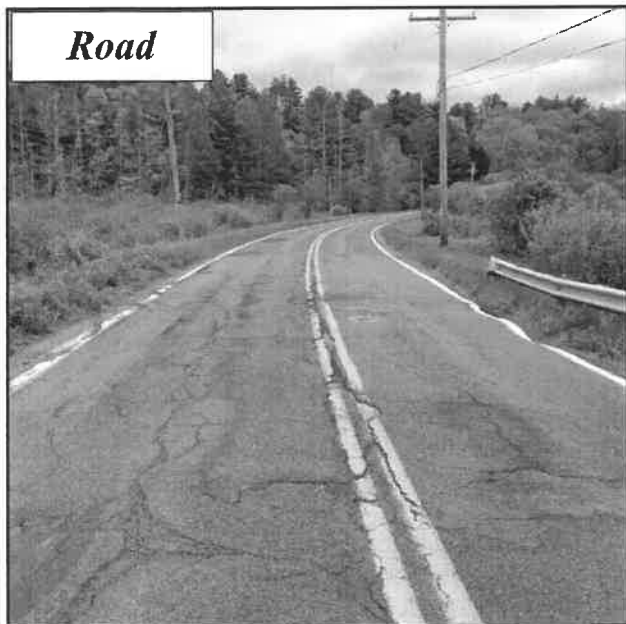
Road

Structure Comments: Outlet completely sub-

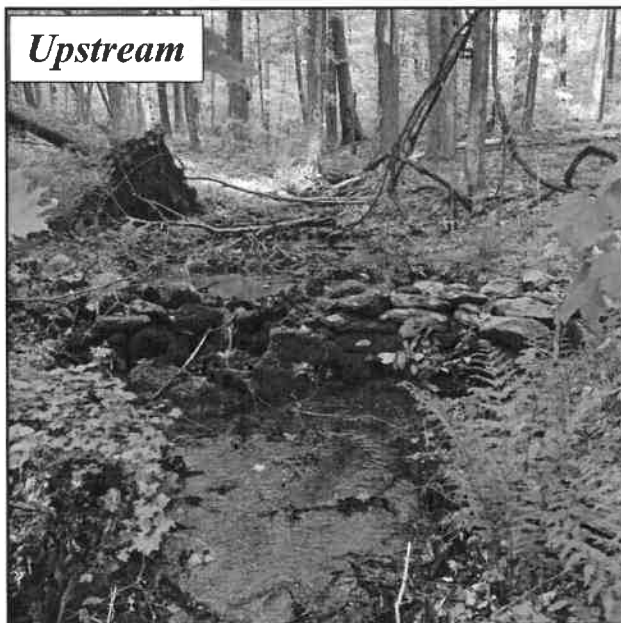
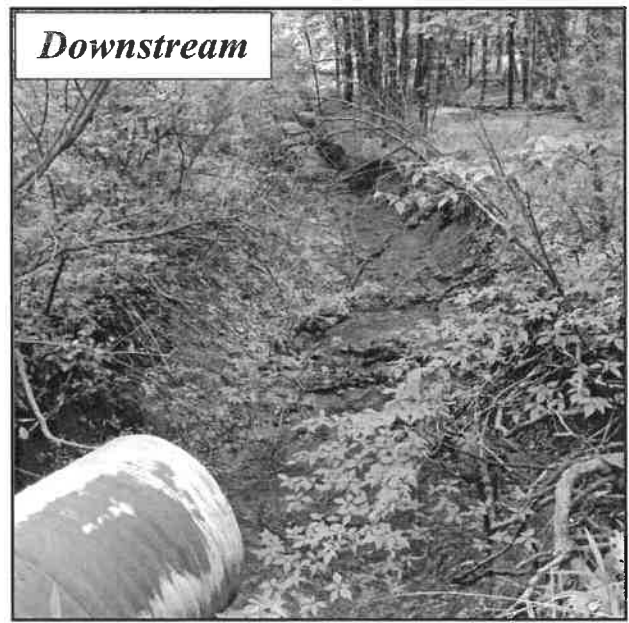
Crossing Comments: Severe erosion downstream; road sediment filling channel at inlet

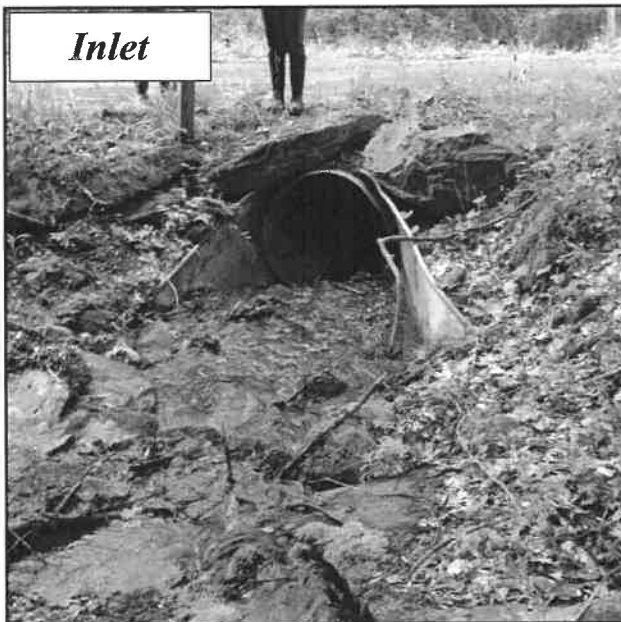
INLET

Inlet Shape/Type: Round Culvert/Wingwalls
Inlet Drop/Grade: Inlet Drop
Dimensions:
Width: 2.7, Height: 3
Substrate/Water Width: 0.9
Water Depth: 0.26

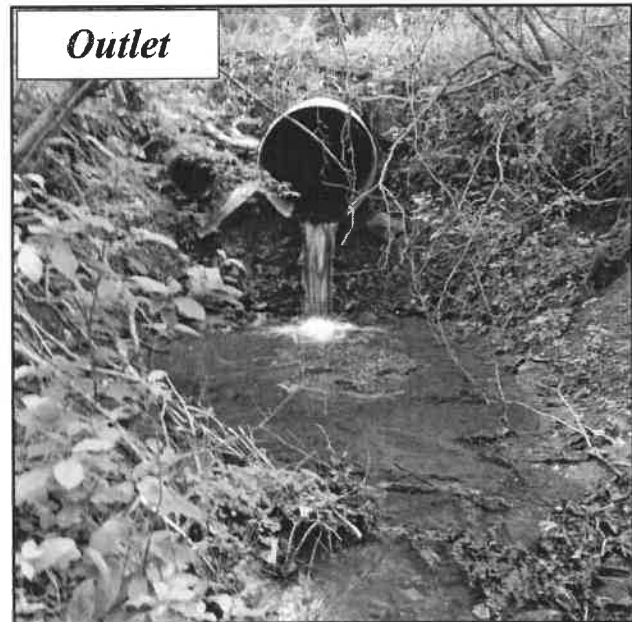
OUTLET

Physical Barrier(s) (Severity): Free Fall (Minor)
Slope (%): 8
Structure Comments: No data

Outlet Shape: Round Culvert
Outlet Drop/Grade: Free Fall
Drop to Stream Surface/Bottom: 2.3/2.8
Dimensions:
Width: 2.9, Height: 3.0
Substrate/Water Width: 1.3
Water Depth: 0.20

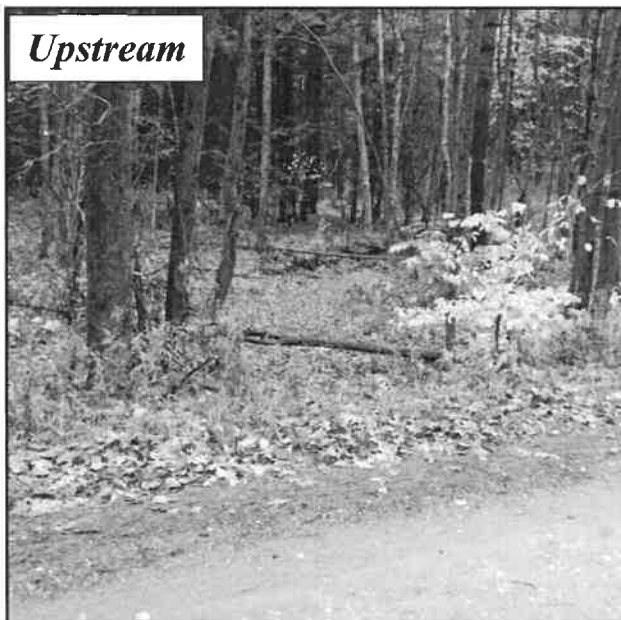
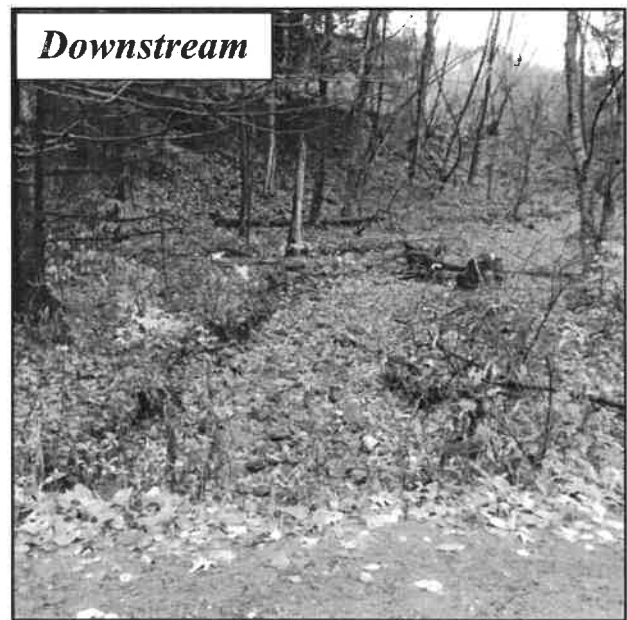
Crossing Comments: Eroded banks evident up and downstream. Difficult to measure bank-full width. Intermittent flow

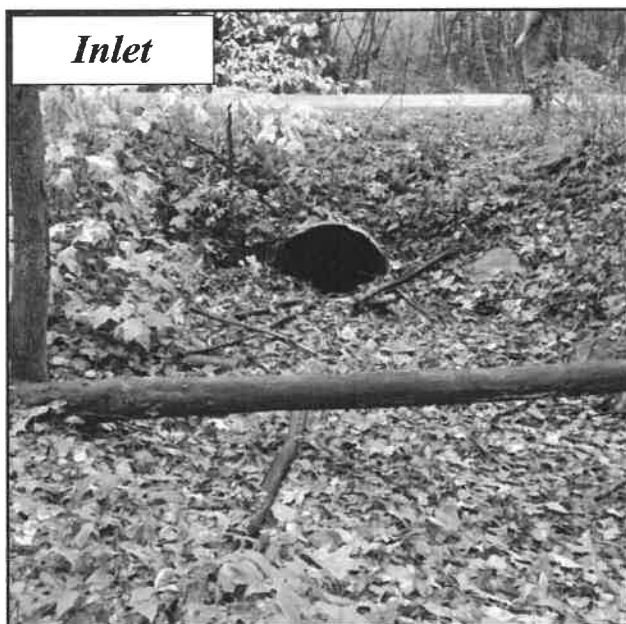
INLET

Physical Barrier(s) (Severity): None
Slope (%): 1
Structure Comments: 1.2 inlet drop, lots of debris, bank erosion

Inlet Shape/Type: Round Culvert/Projecting
Inlet Drop/Grade: Inlet Drop
Dimensions:
Width: 3, Height: 3
Substrate/Water Width: 0
Water Depth: 0

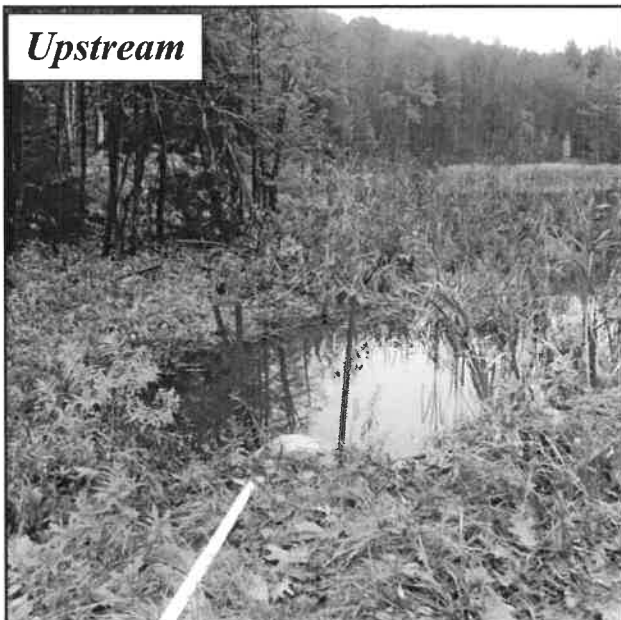
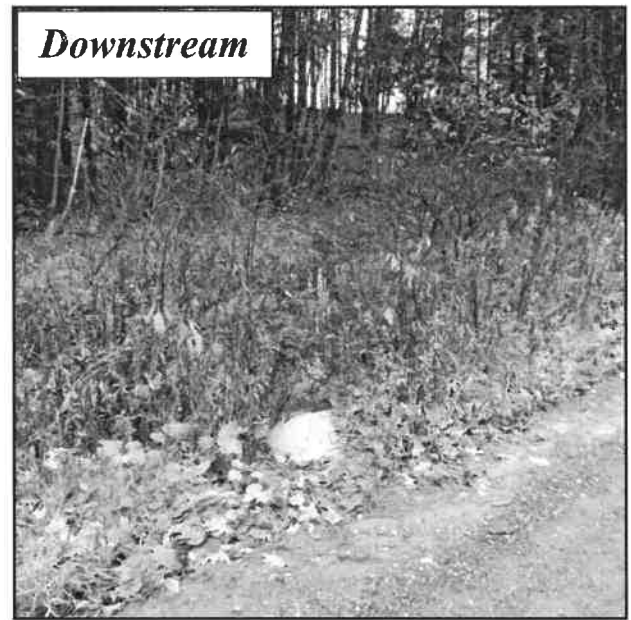
Crossing Comments: Beaver dam and impoundment upstream. Beaver dam and debris at inlet is creating inlet drop.

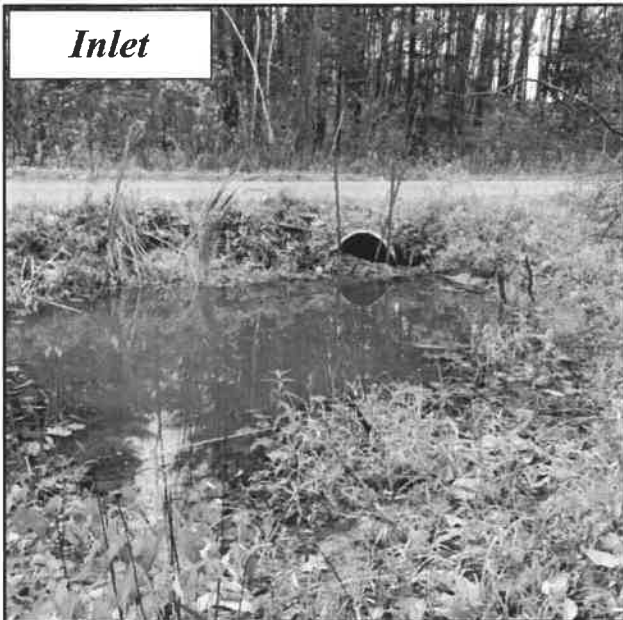
INLET

Structure Comments: 1.3 foot inlet drop

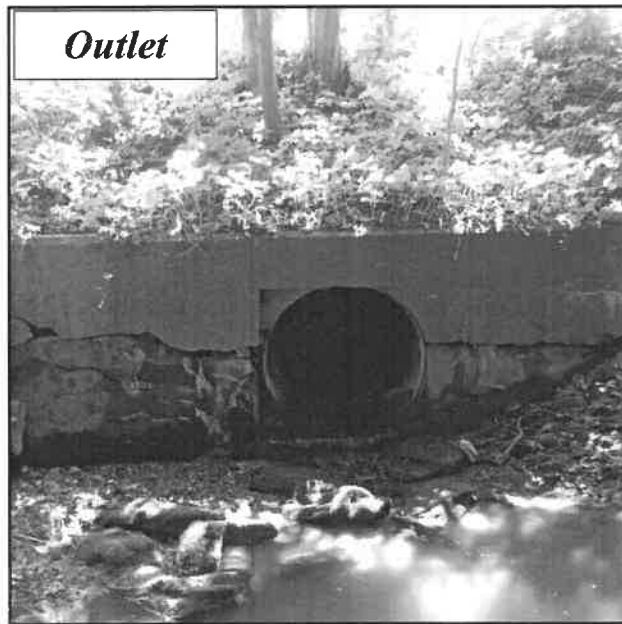
**OUTLET**

Outlet Shape: Round Culvert
 Outlet Drop/Grade: Free Fall
 Drop to Stream Surface/Bottom: 0.4/0.7
 Dimensions:
 Width: 3.0, Height: 3.0
 Substrate/Water Width: 1.5
 Water Depth: 0.25

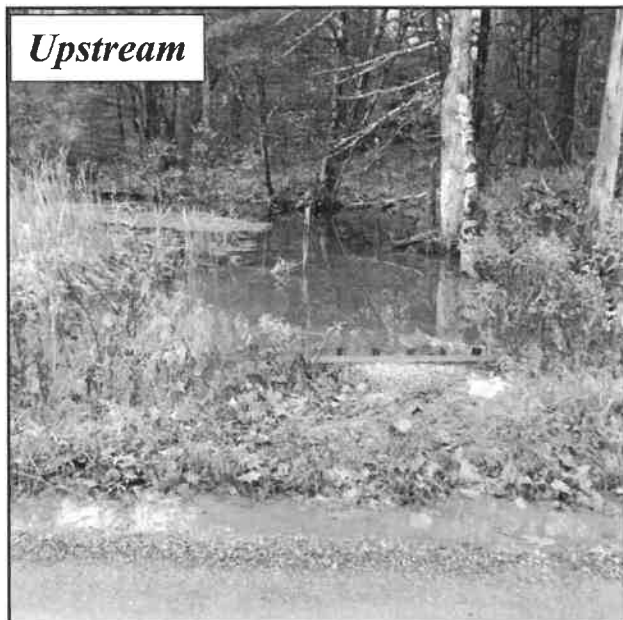
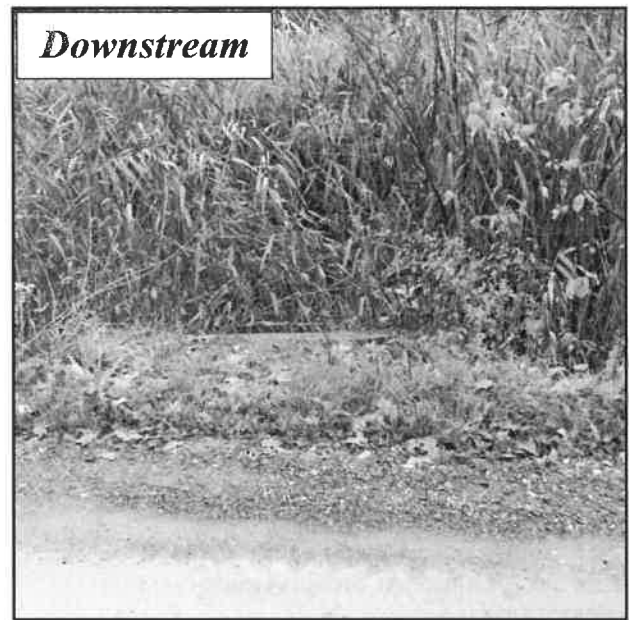
Crossing Comments: Sediment from storm water in inlet wetland area, beaver impoundment
up and downstream of the crossing

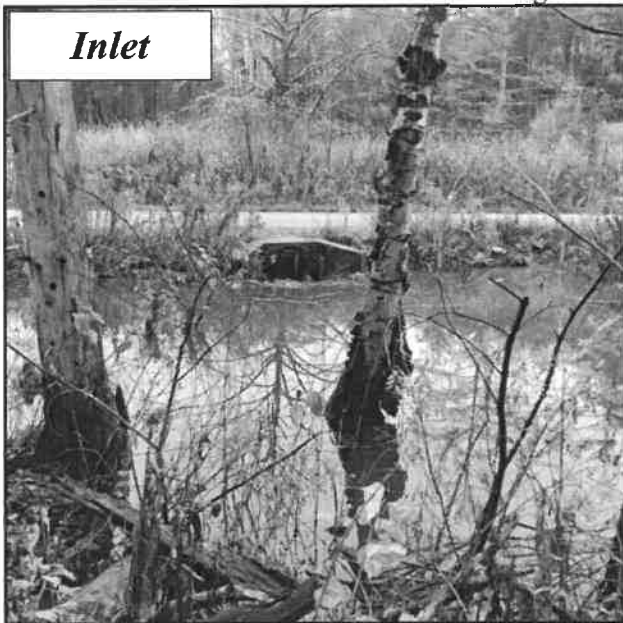
INLET

Structure Comments: Stakes at inlet and outlet. Accumulation of debris against stakes is creating a 2 foot inlet drop and a severe physical barrier

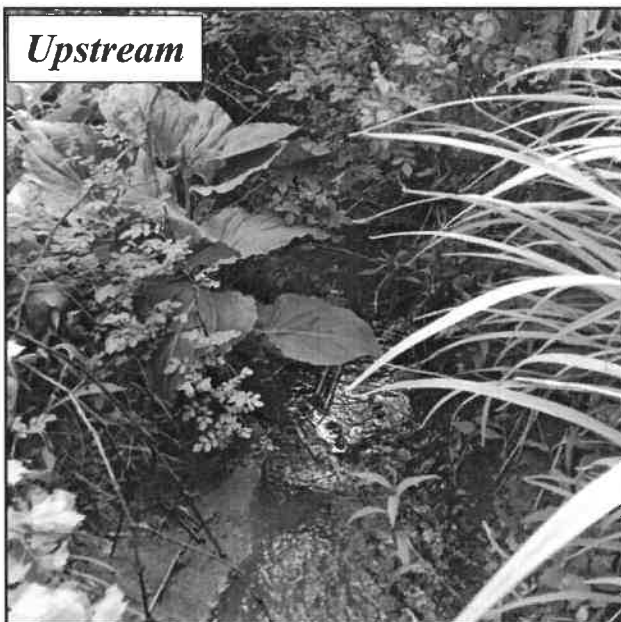
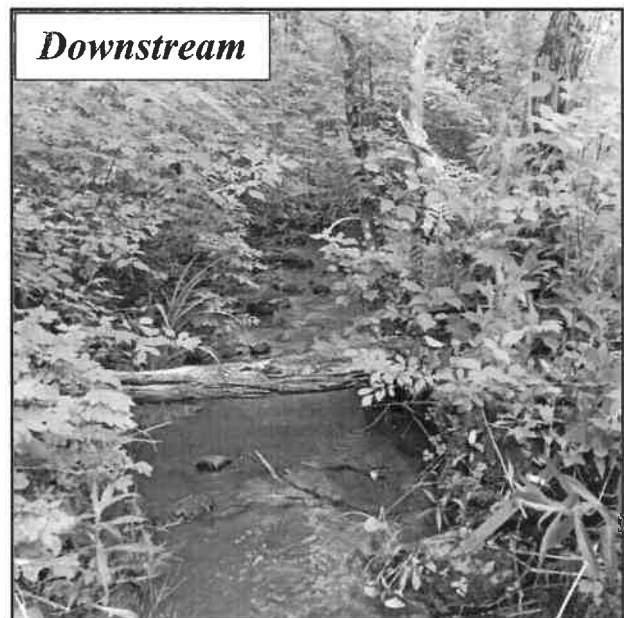
Crossing Comments: Pipe is rotting in multiple locations

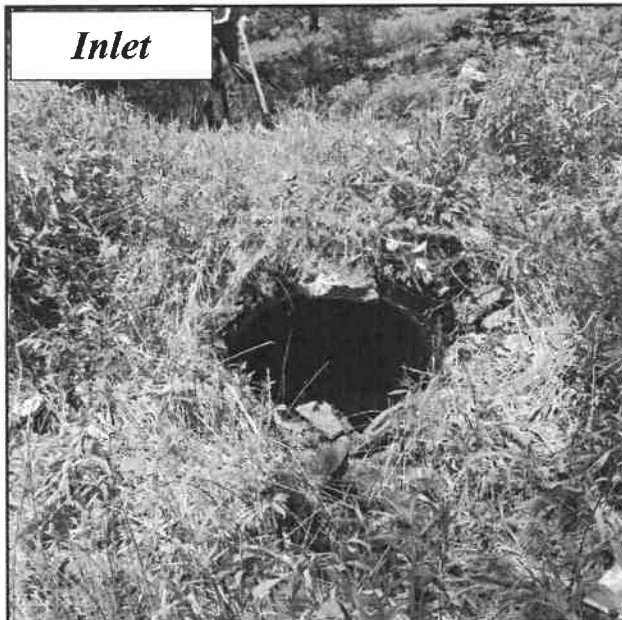
INLET

Physical Barrier(s) (Severity): None
Slope (%): 4
Structure Comments: Upstream is inaccessible due to very thick vegetation. 0.7 foot inlet drop. Road sediment evident in stream

Inlet Shape/Type: Round Culvert/Wingwalls
Inlet Drop/Grade: Inlet Drop
Dimensions:
Width: 2.5, Height: 2.3
Substrate/Water Width: 1.1
Water Depth: 0.2

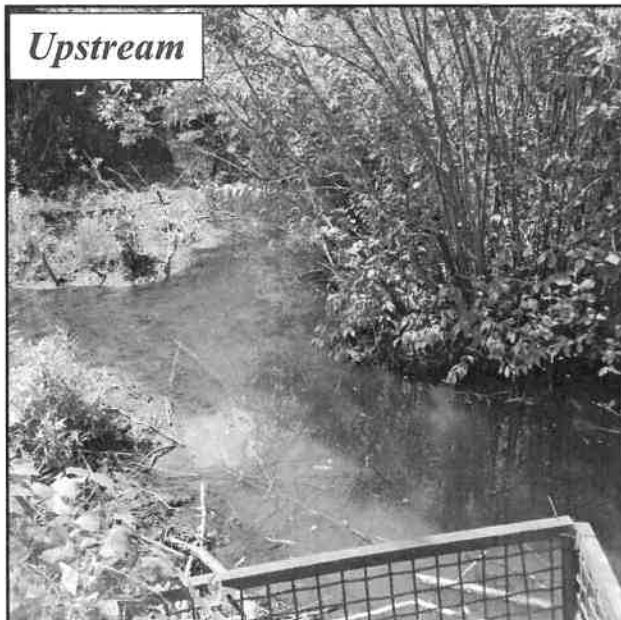
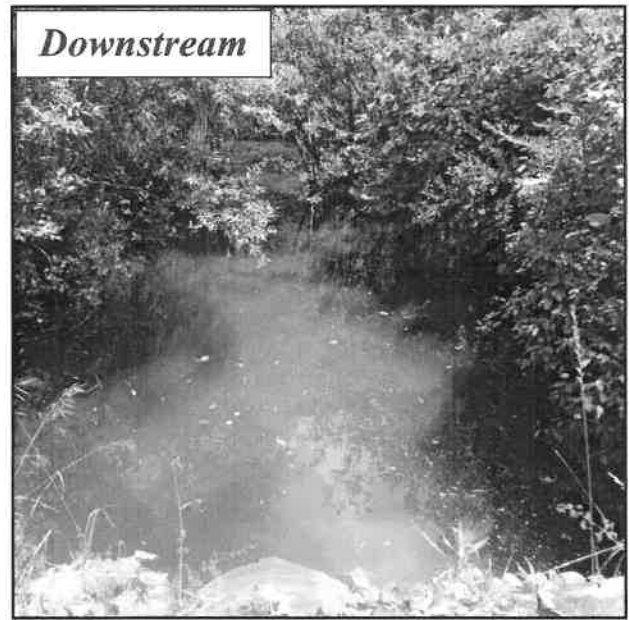
Crossing Comments: Deep water at inlet made it difficult to get inlet photo.

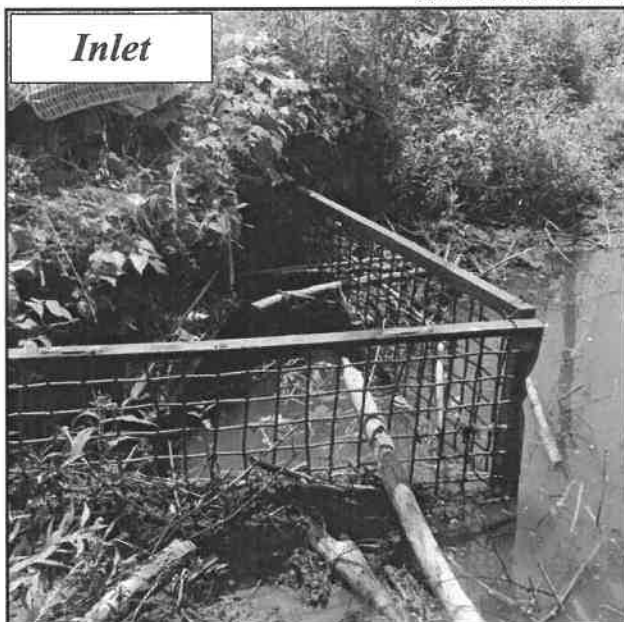
Structure Comments: Inlet is deformed and broken, inlet width is averaged. The crossing banks are covered in poison ivy and inlet side has deep thick mud so it is difficult to photo.

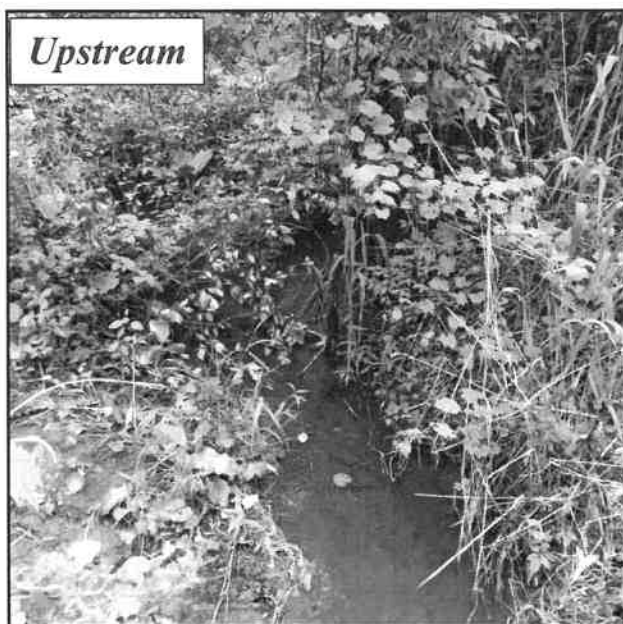
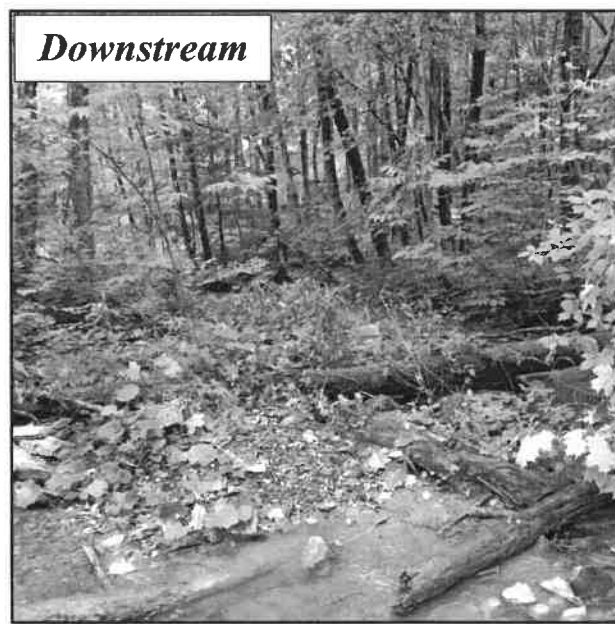
Crossing Comments: Road sediment is being washed into stream at both inlet and outlet

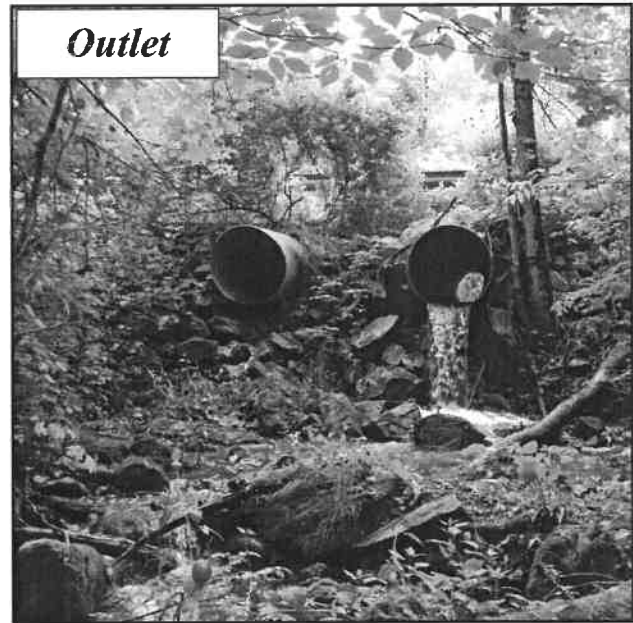
Outlet Shape: Round Culvert
Outlet Drop/Grade: Free Fall
Drop to Stream Surface/Bottom: 3.5/4.0
Dimensions:
Width: 3.0, Height: 3.0
Substrate/Water Width: 1.6
Water Depth: 0.30

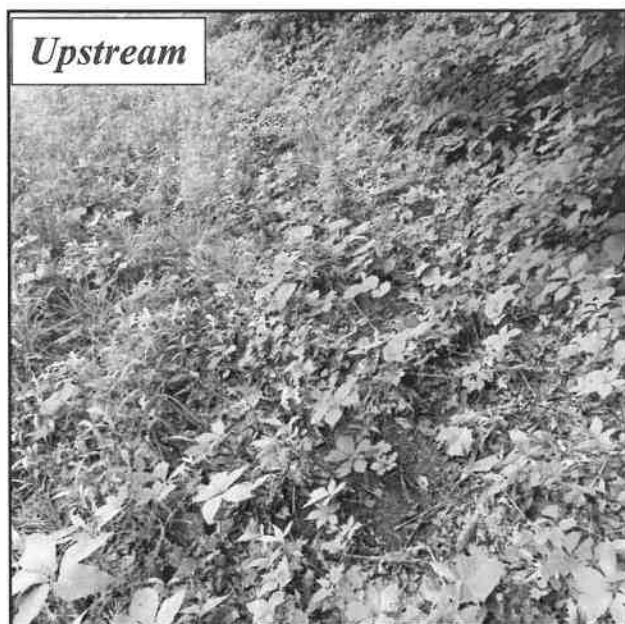
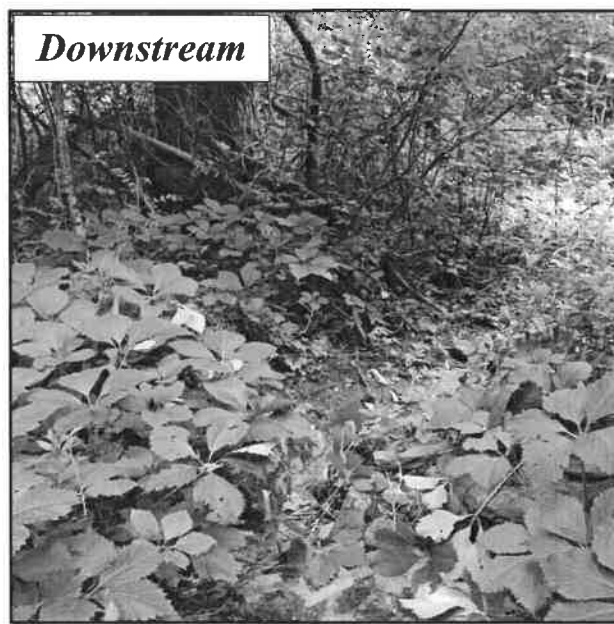
Crossing Comments: Inlet is buried under a grate

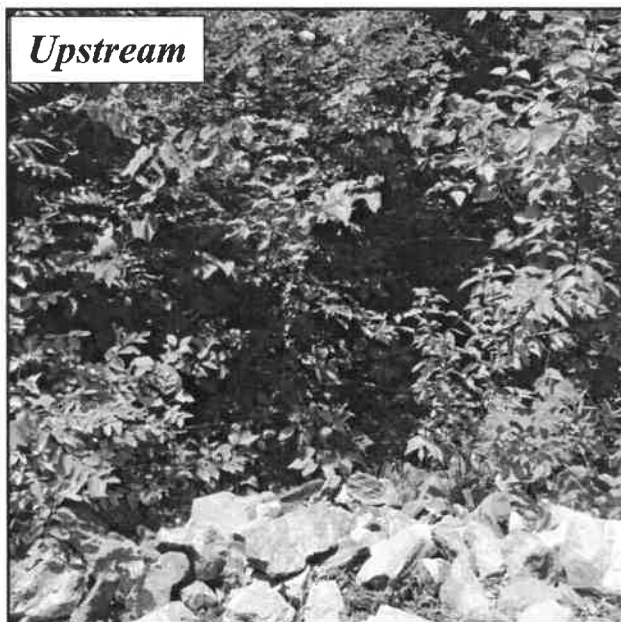
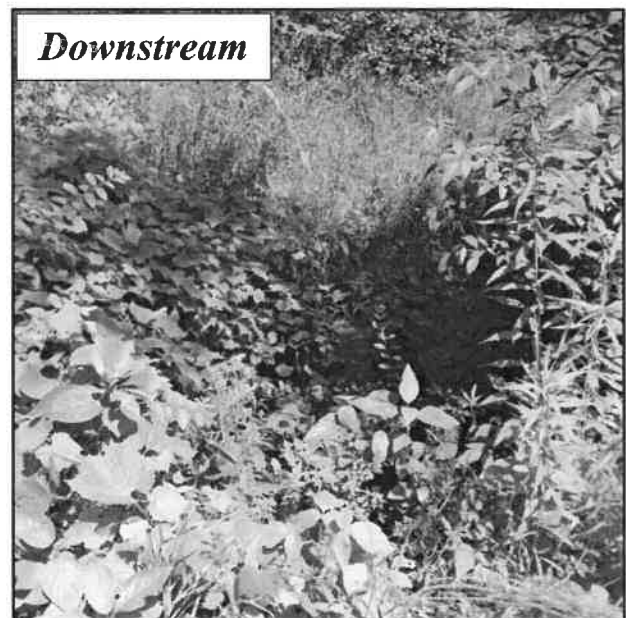
Crossing Comments: Inlet pipe is not visible possibly buried under rip rap. Road fill estimated

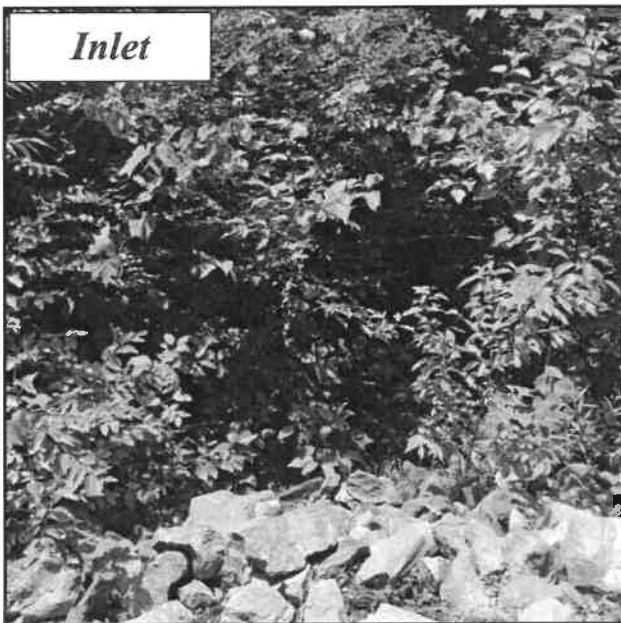
Structure Comments: Inlet pipe not found - maybe buried under rip rap.

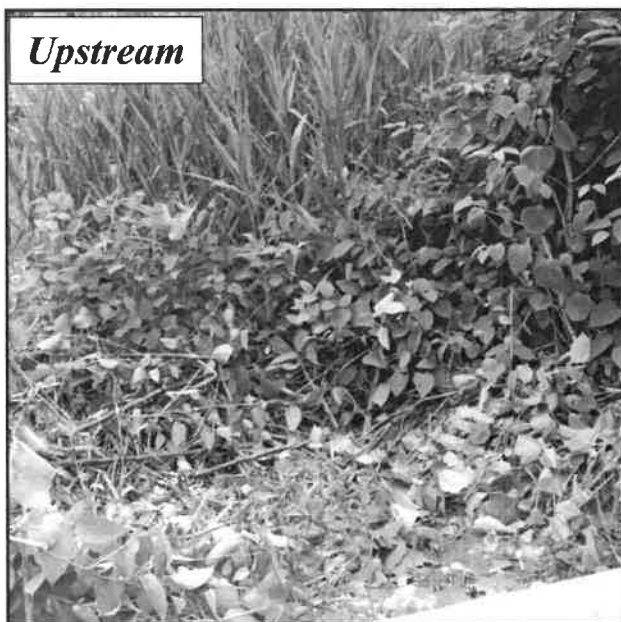
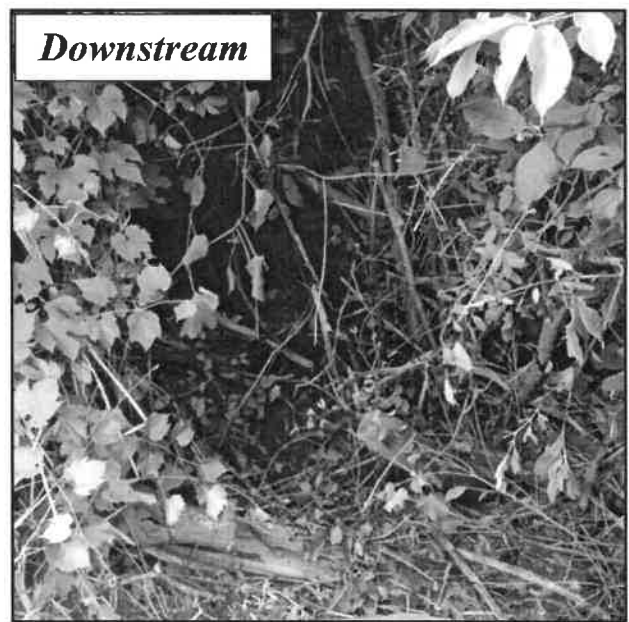
Crossing Comments: One side of pipe completely buried, possibly outlet The side measured had very thick vegetation and upstream was difficult to access.
