Town of West Stockbridge Road-Stream Crossing Inventory

Produced by
The Housatonic Valley Association
2021

Executive Summary – August 2021

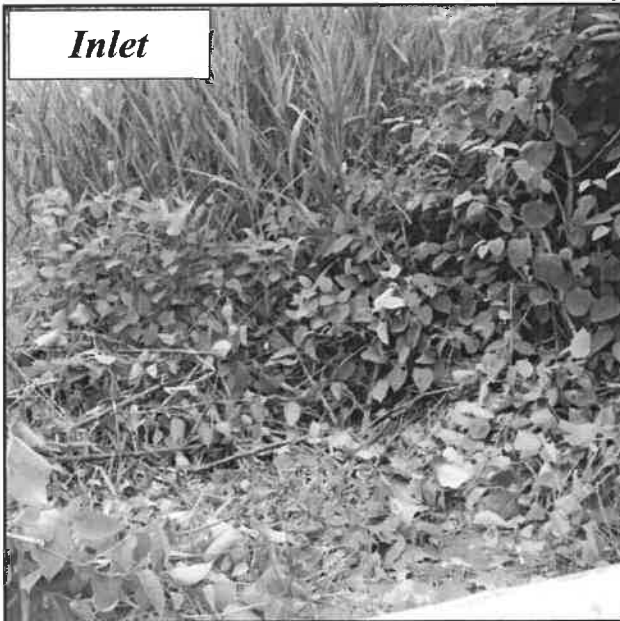
Inlet

Structure length estimated based on previous UMass data.

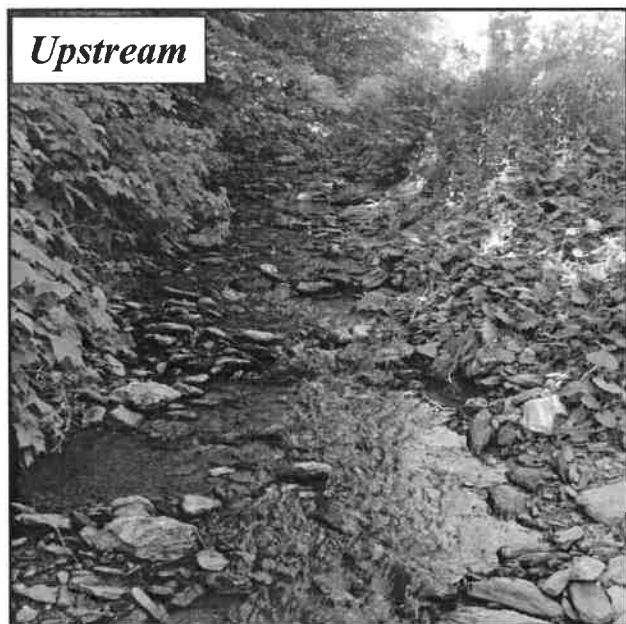
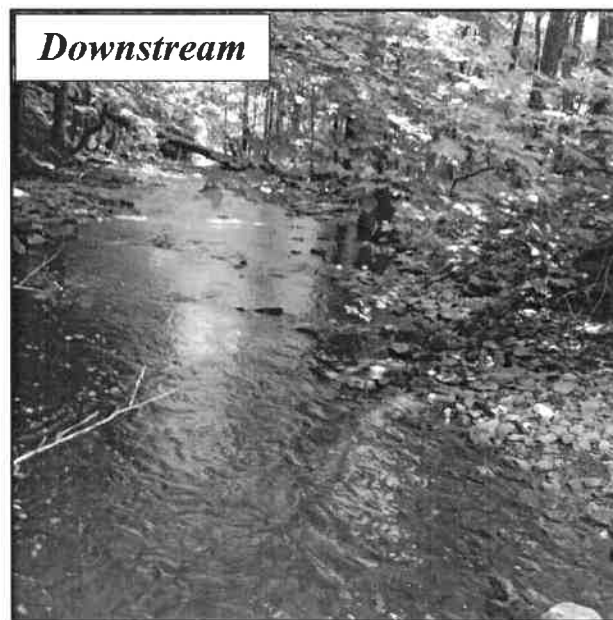
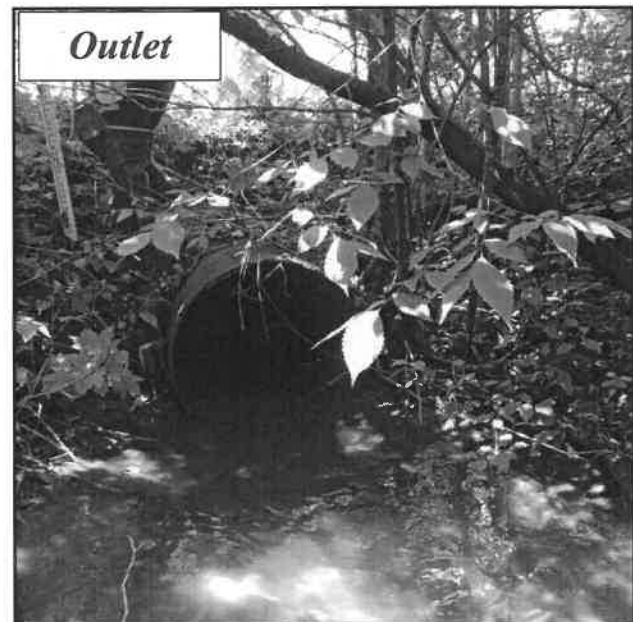
Crossing Comments: Scour pools on both culverts. Outlet picture is structure 1, structure 2 outlet will be under other photo 2.

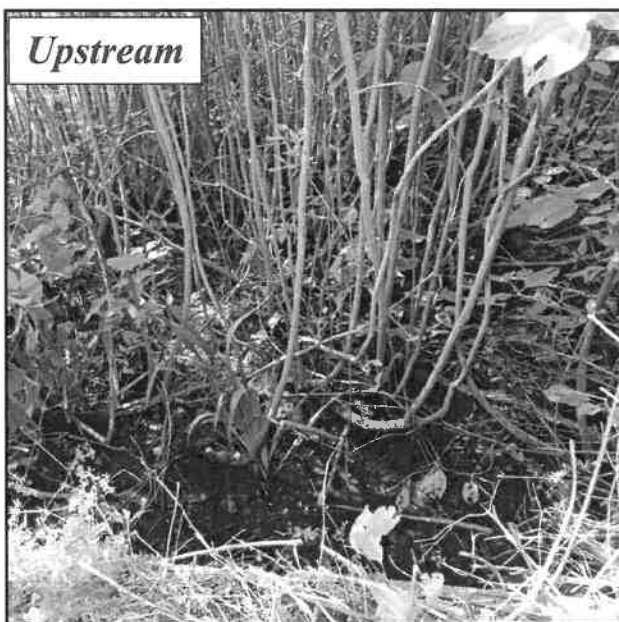
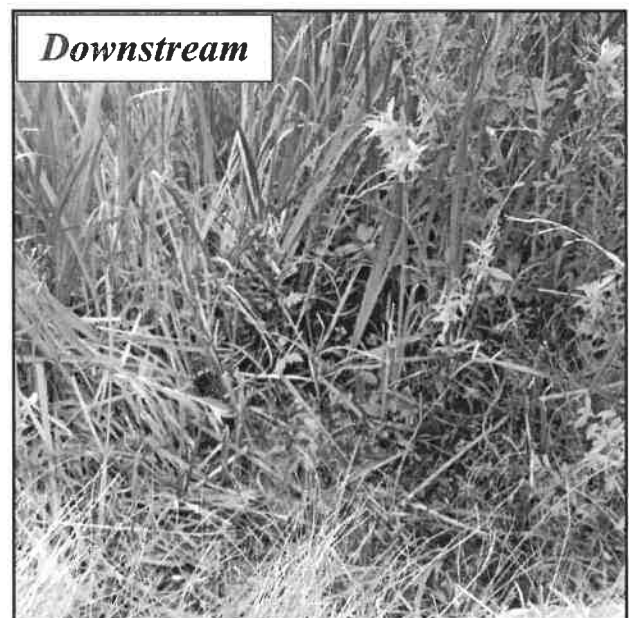
Crossing Comments: Inlet photo very hard to get because of thick vegetation

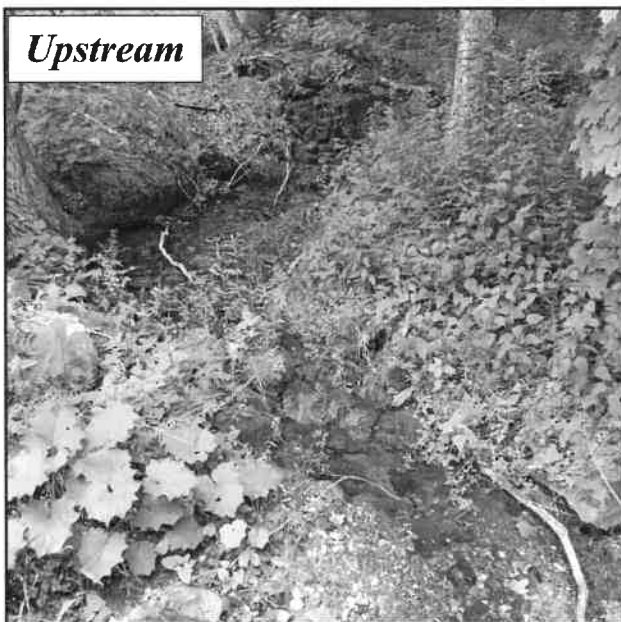
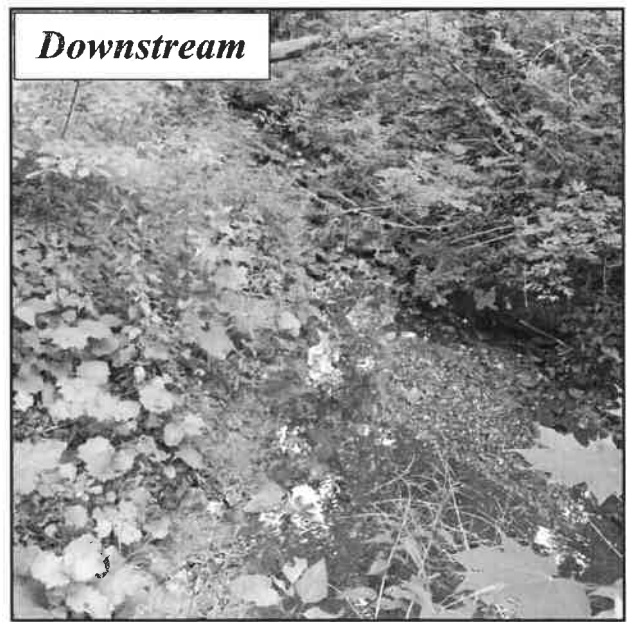
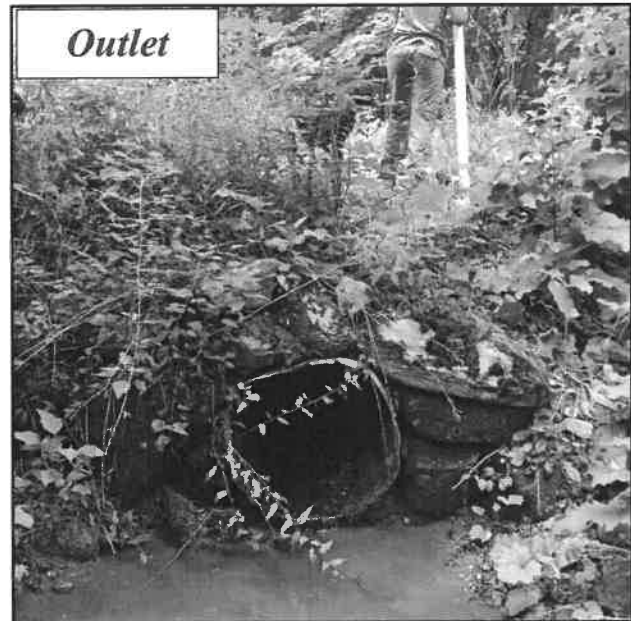
Crossing Comments: Property owner nearby reported that this crossing overtops about once every couple of years. This occurs when there is a long period of rain or a significant rain when the ground is frozen. He indicated that there are trout in this stream and was concerned about the perched nature of the culvert.

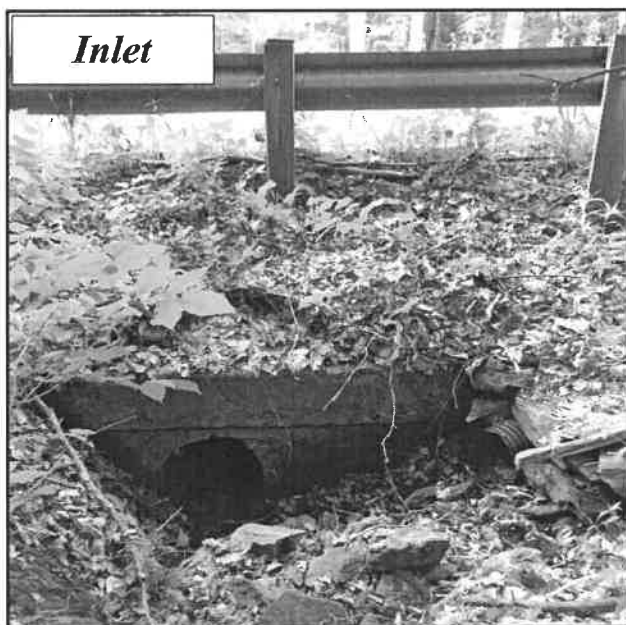
Inlet

Structure Comments: One storm water pipe next to inlet

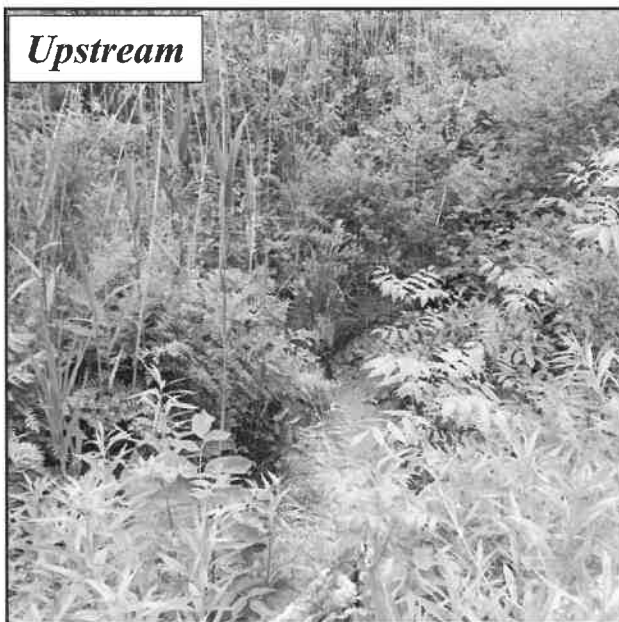
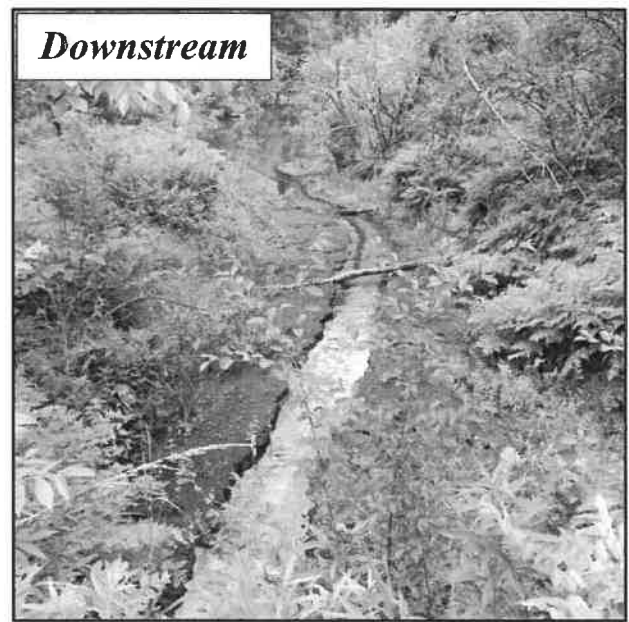
Crossing Comments: Crossing is caving downward around halfway through the pipe about 20 percent

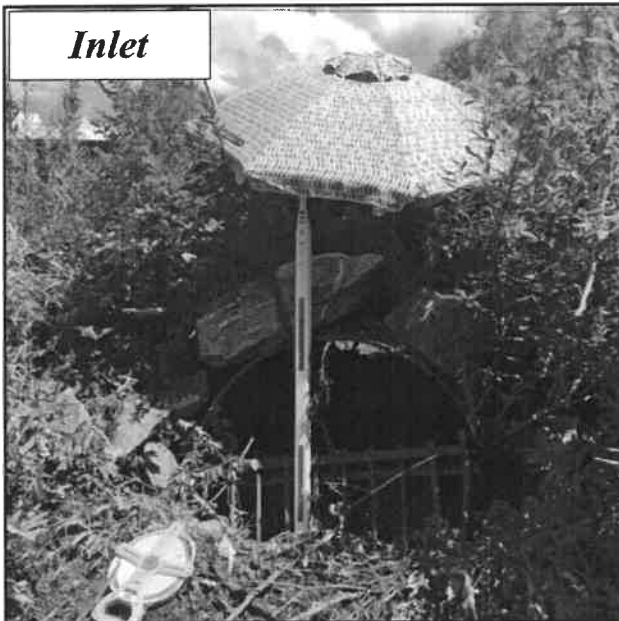
Inlet

Structure Comments: Pipe edge deformed at inlet, thick
mud inside pipe but stream is also dry and muddy.

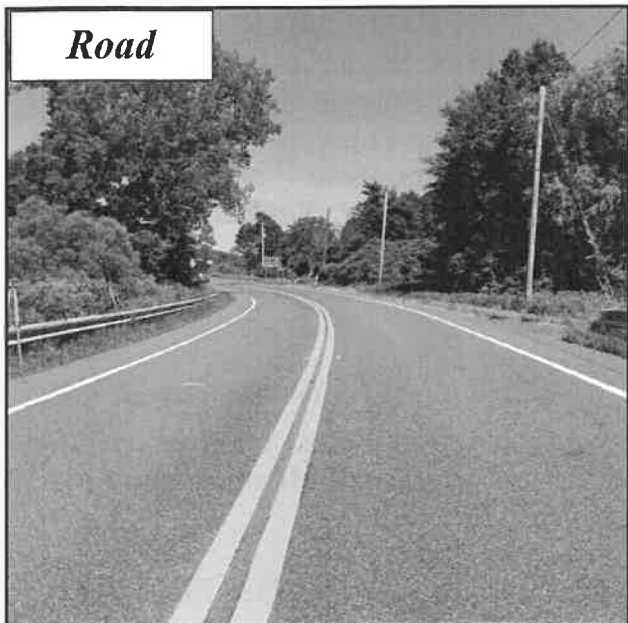
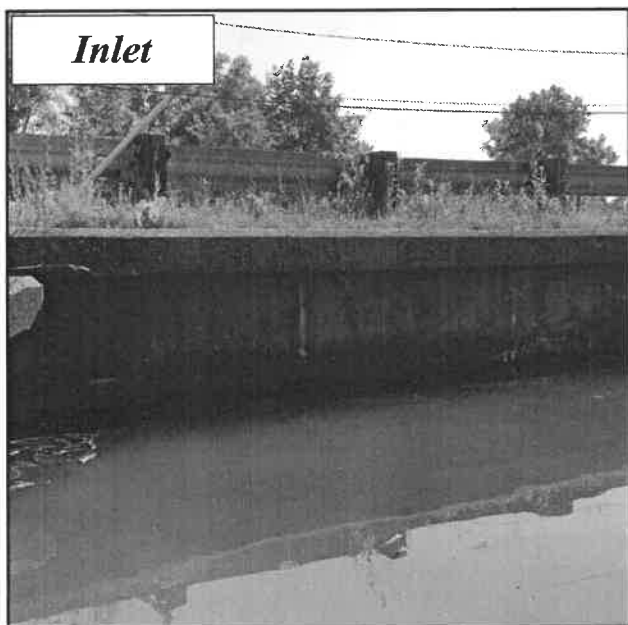
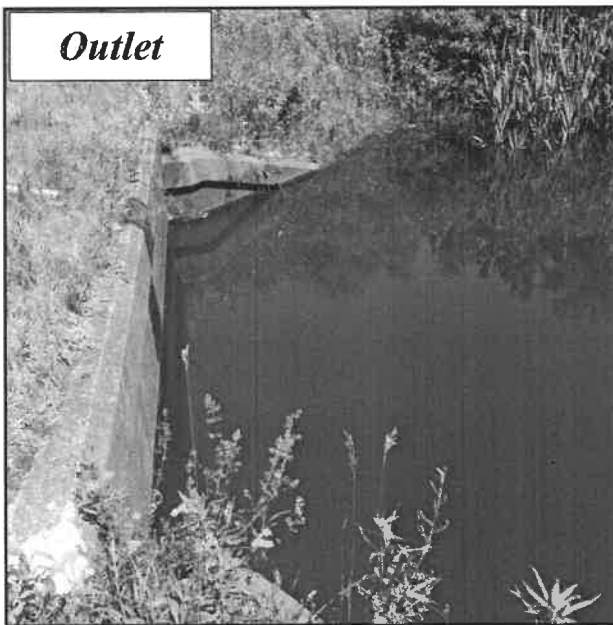
Crossing Comments: Stream crossing and many measurements and photos are almost completely inaccessible due to high water from wetland. May be more accessible during extremely low flow conditions.

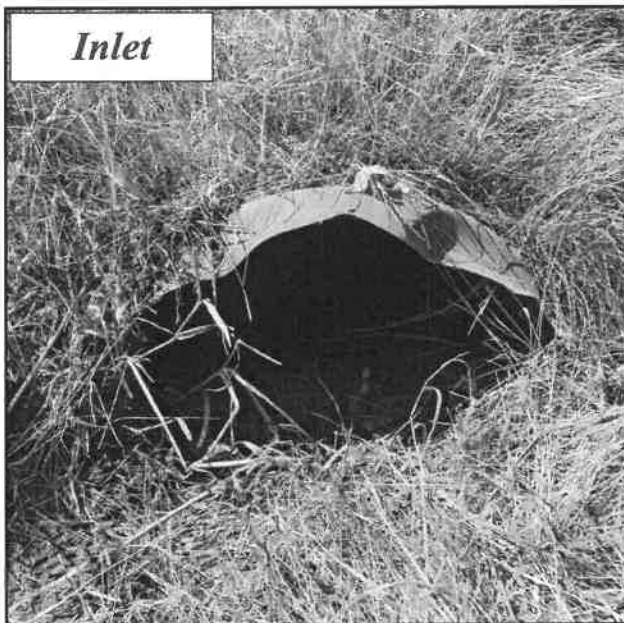
INLET

Structure Comments: Inlet is half buried

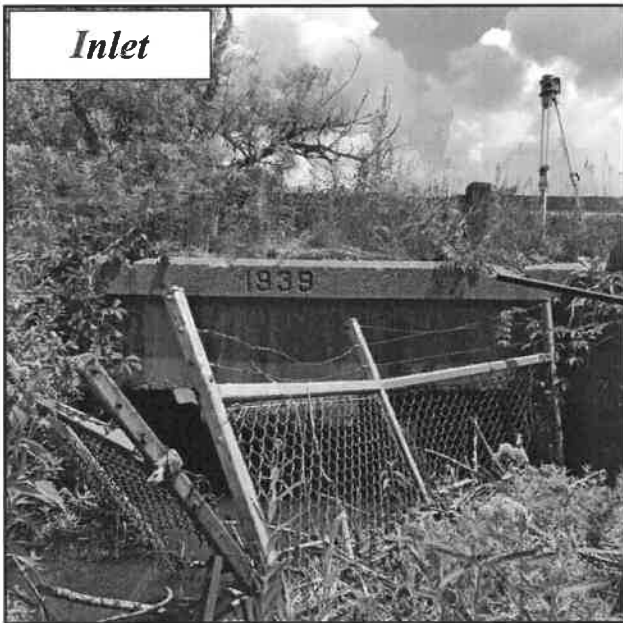
**INLET**

Physical Barrier(s) (Severity): Debris/Sediment/
 Rock, Fencing (Severe)
 Slope (%): 0
 Structure Comments: No data

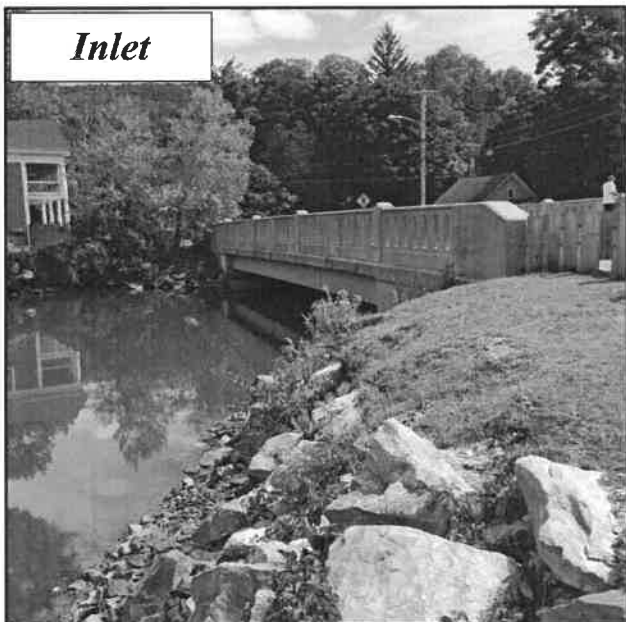
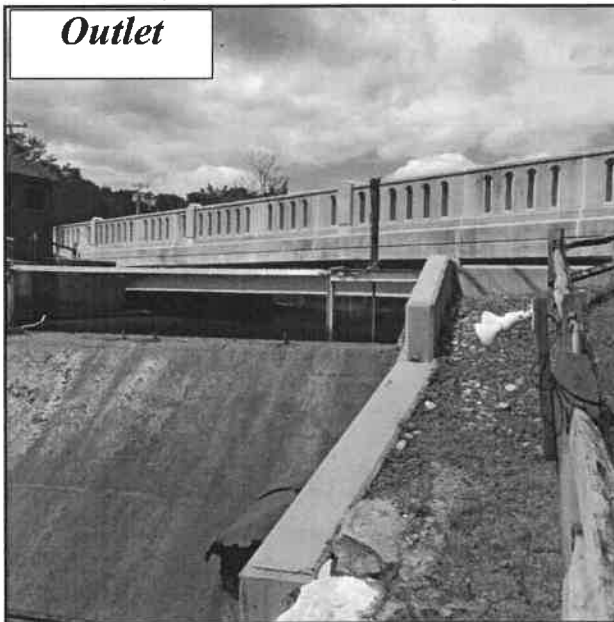
Structure Comments: Dam spillway at outlet is approximately 12 feet high. Height and water depth estimated as it was inaccessible to measure. Water depth and velocity matches upstream Shaker Mill Pond but not the river downstream. Structure substrate is unknown, but it is assumed to be 100 percent as it is a bridge.

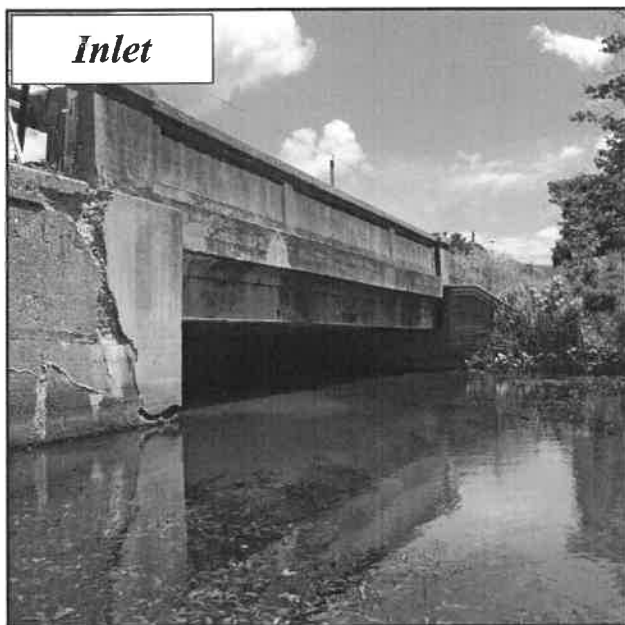
INLET

Crossing Comments: Some crumbling of the concrete on the right side of the inlet. Built in 1924. Connects Crane Lake with Shaker Mill Pond, possibly Flat Brook

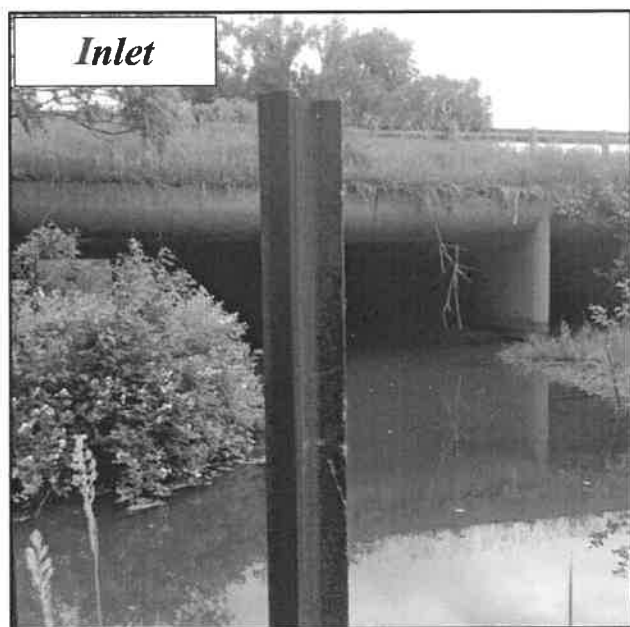
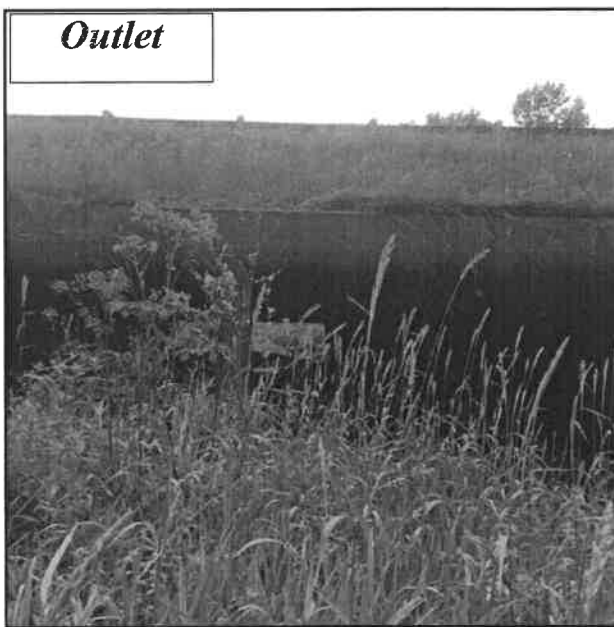
Structure Comments: Cell 1 of this culvert is full of water, as is cell 2.

Cell 3 is completely dry and likely provides year-round terrestrial passage.

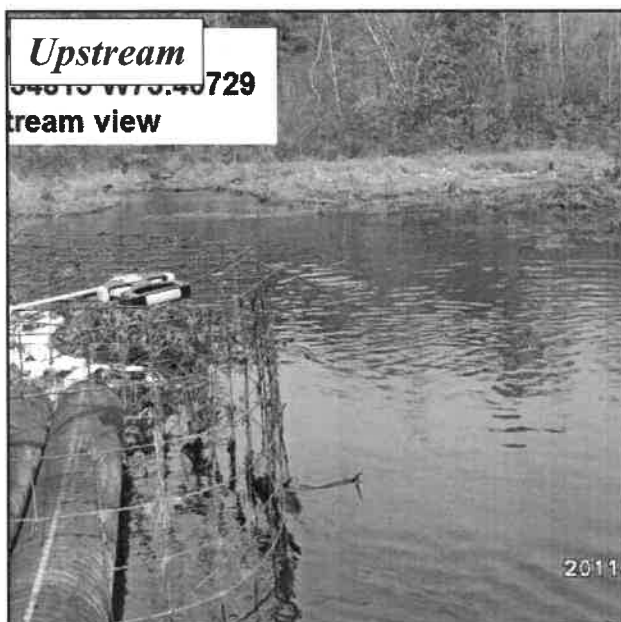
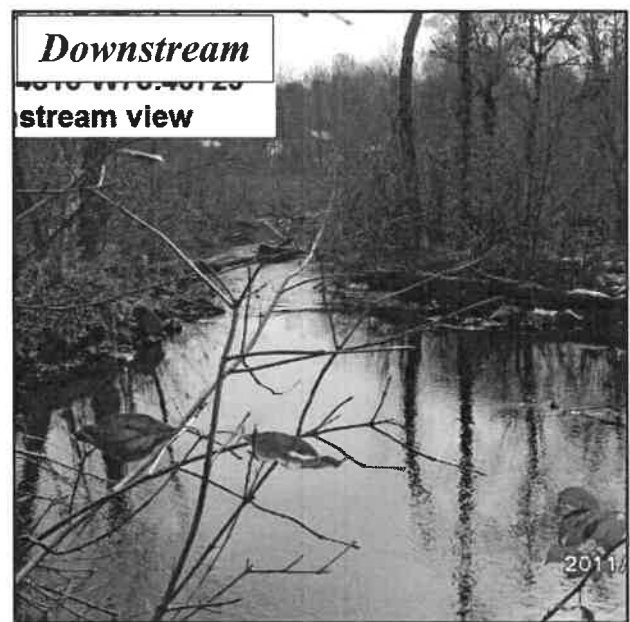
Crossing Type: Partially Inaccessible
Number of structures/cells: 2
Condition: Poor
Constriction: Severe
Alignment: Flow-Aligned
Internal Features/Structures: No data

Scour Pool: Large
Bankfull Width (feet): 0.0
Water Depth/Velocity Matches Stream: Yes/No-
Slower
Structure Substrate Type: Silt
Structure Substrate Matches Stream? Compara-
ble

Crossing Comments: Both inlets are buried— some data is from the older UMass survey.
Photos are also from the UMass survey.

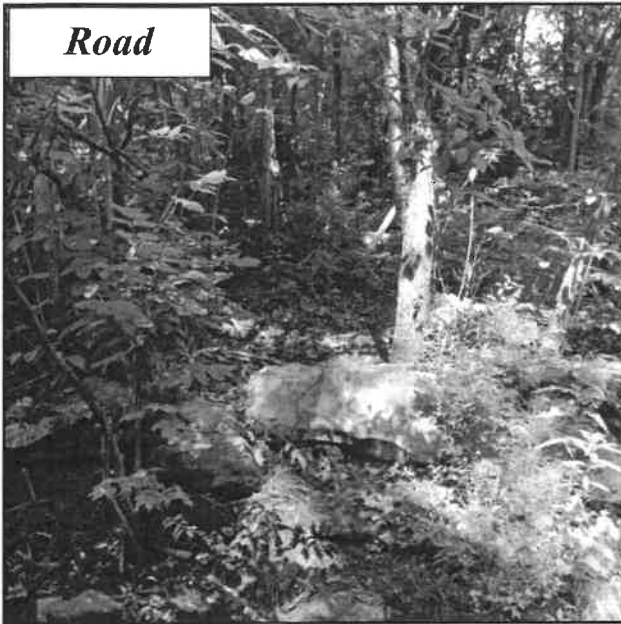
Road Type: Trail

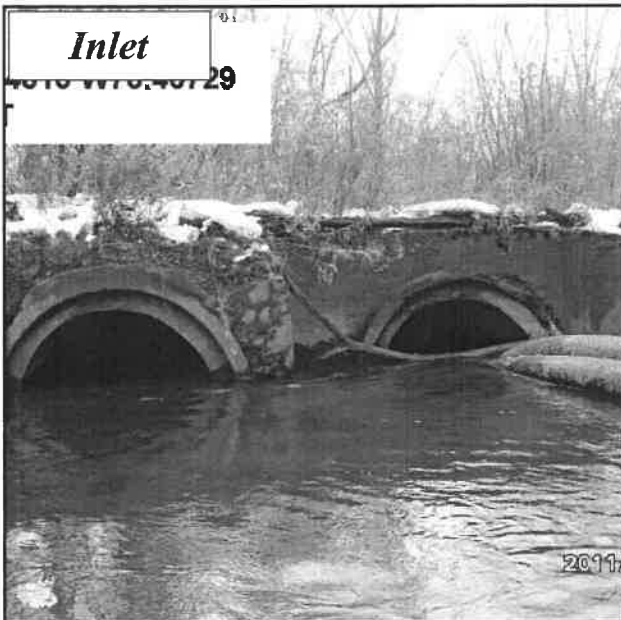
Inlet Shape/Type: Pipe Arch/Elliptical Culvert/
Headwall

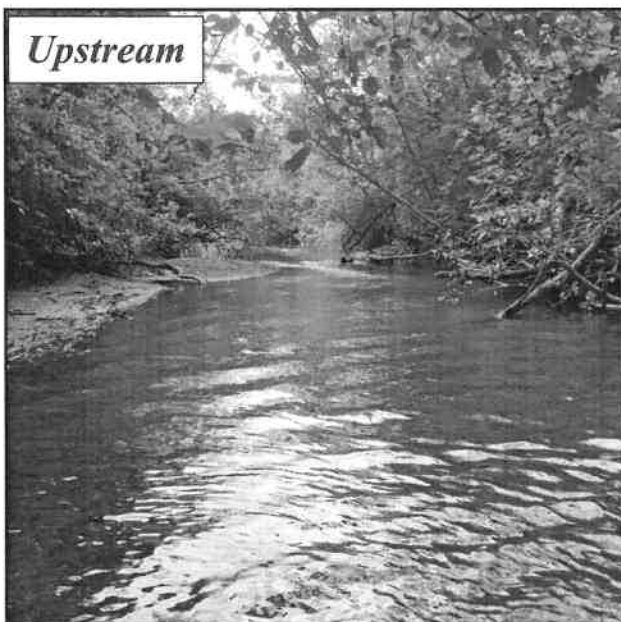
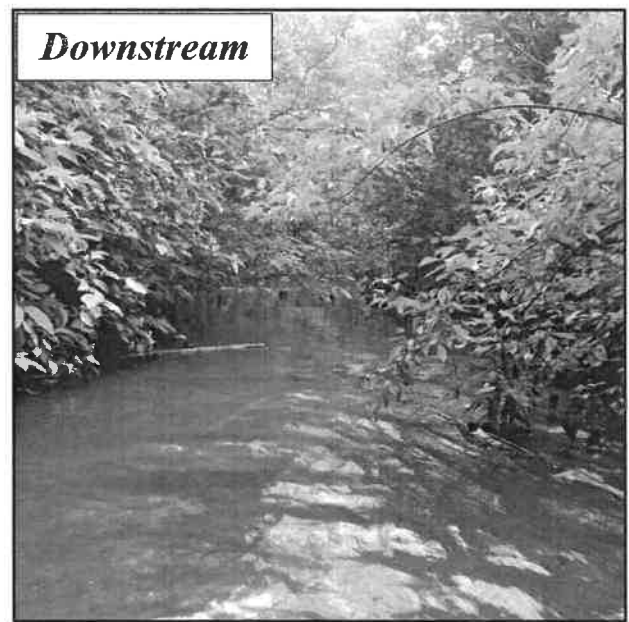
Crossing Type: Bridge
Number of structures/cells: 1
Condition: OK
Constriction: Moderate
Alignment: Flow-Aligned
Internal Features/Structures: None

Scour Pool: None
Bankfull Width (feet): 35.0
Water Depth/Velocity Matches Stream: Yes/Yes
Structure Substrate Type: Gravel
Structure Substrate Matches Stream? Contrasting

Crossing Comments: Private crossing

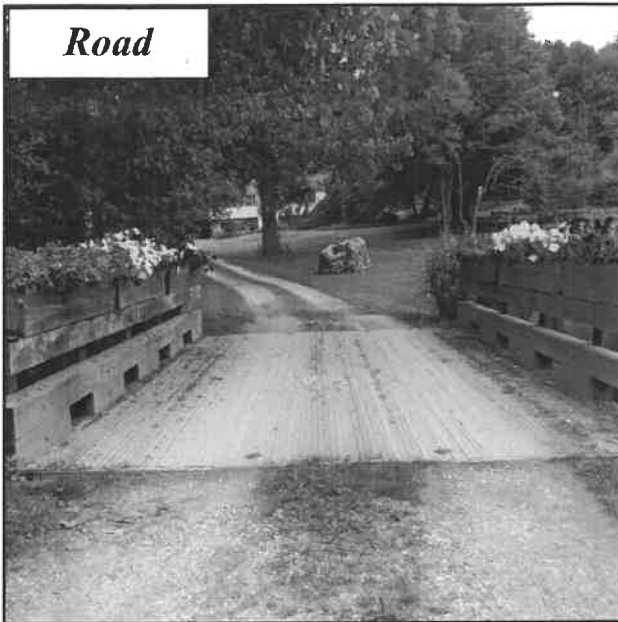
Road Type: Driveway
Road Fill Height (feet): 0
Road Ownership: Private

Physical Barrier(s) (Severity): Debris/Sediment/
Rock (Minor)
Slope (%): No data
Structure Comments: No data

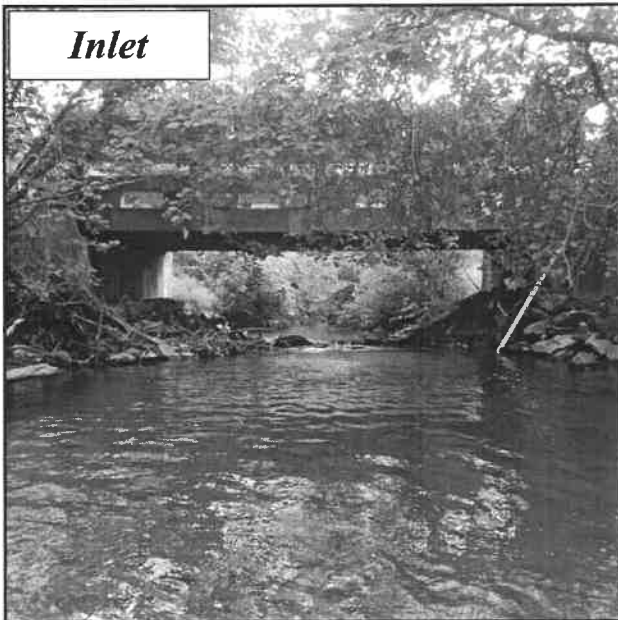
Inlet Shape/Type: Box/Bridge with Abutments/
Headwall and Wingwalls
Inlet Drop/Grade: At Stream Grade
Dimensions:
Width: 21.4, Height: 5
Substrate/Water Width: 9
Water Depth: 0.3

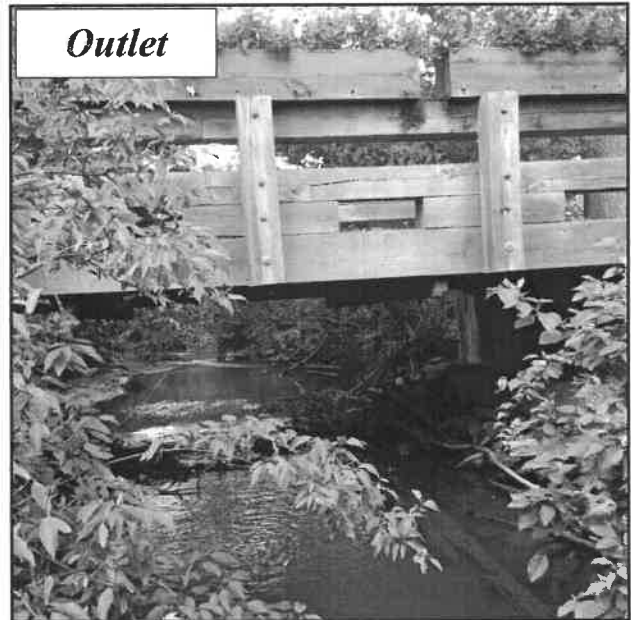
Outlet Shape: Box/Bridge with Abutments
Outlet Drop/Grade: At Stream Grade
Drop to Stream Surface/Bottom: 0.0/0.0
Dimensions:
Width: 21.4, Height: 6.3
Substrate/Water Width: 10.0
Water Depth: 1.40
